PE08-066

FORD

APPENDIX G

ENGINEERING REVIEW

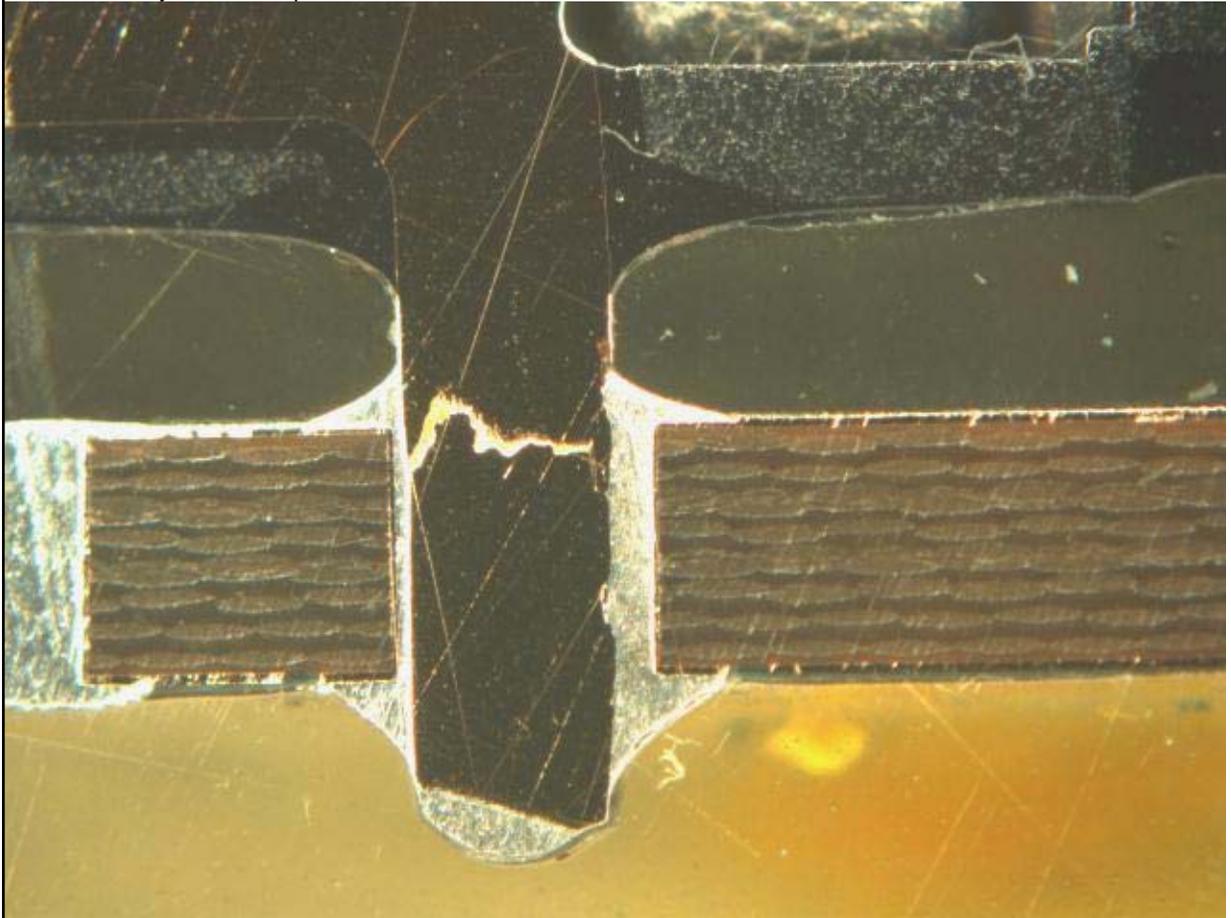
Image 1 - Cross section of sample 1. This is a good solder joint. The crack in the middle of the lead is an artifact of the cross sectioning.  
The lead is very thin at this point.

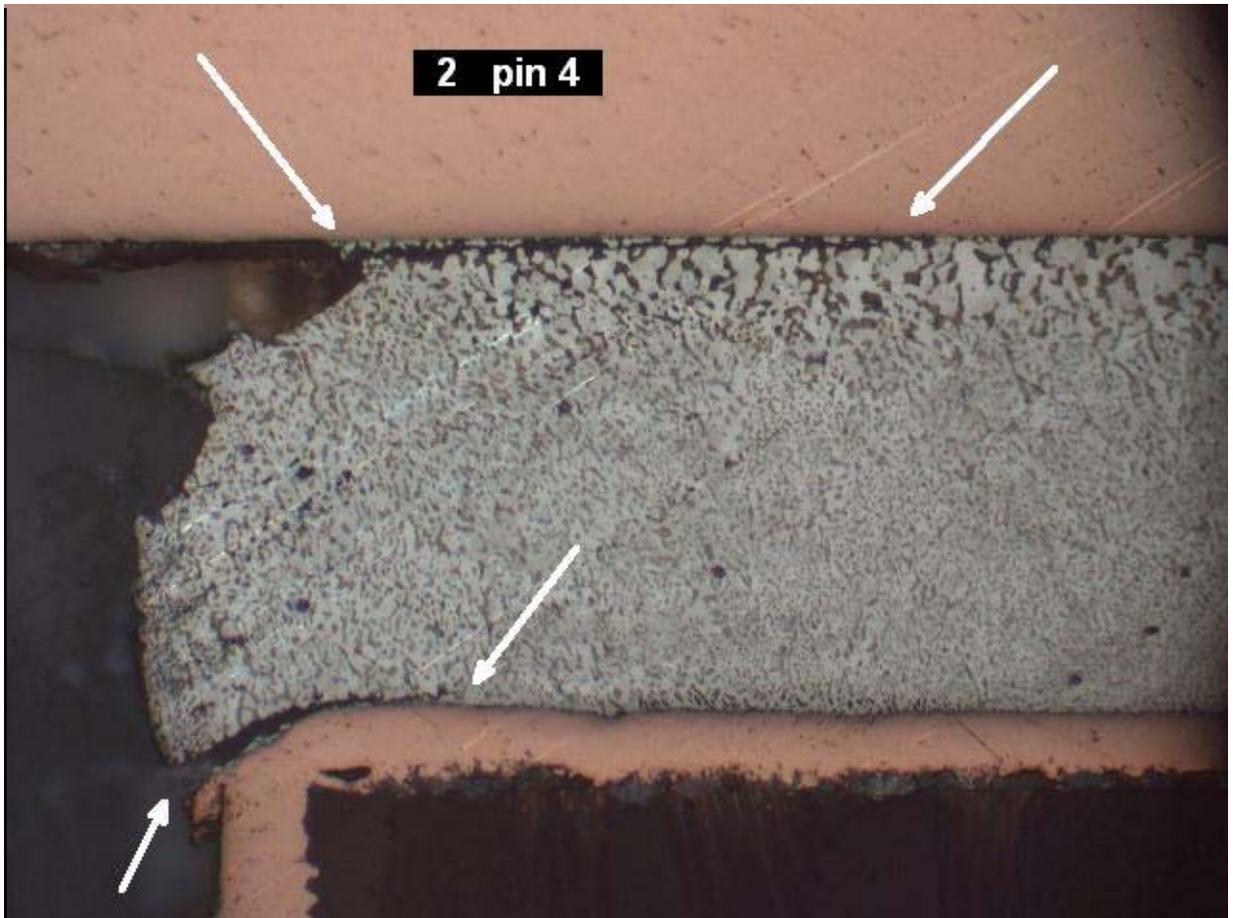
Image 3 Higher magnification image. The black arrows point to a thin coating of epoxy from the relay that coats the pin and prevents solder wetting to the pin.

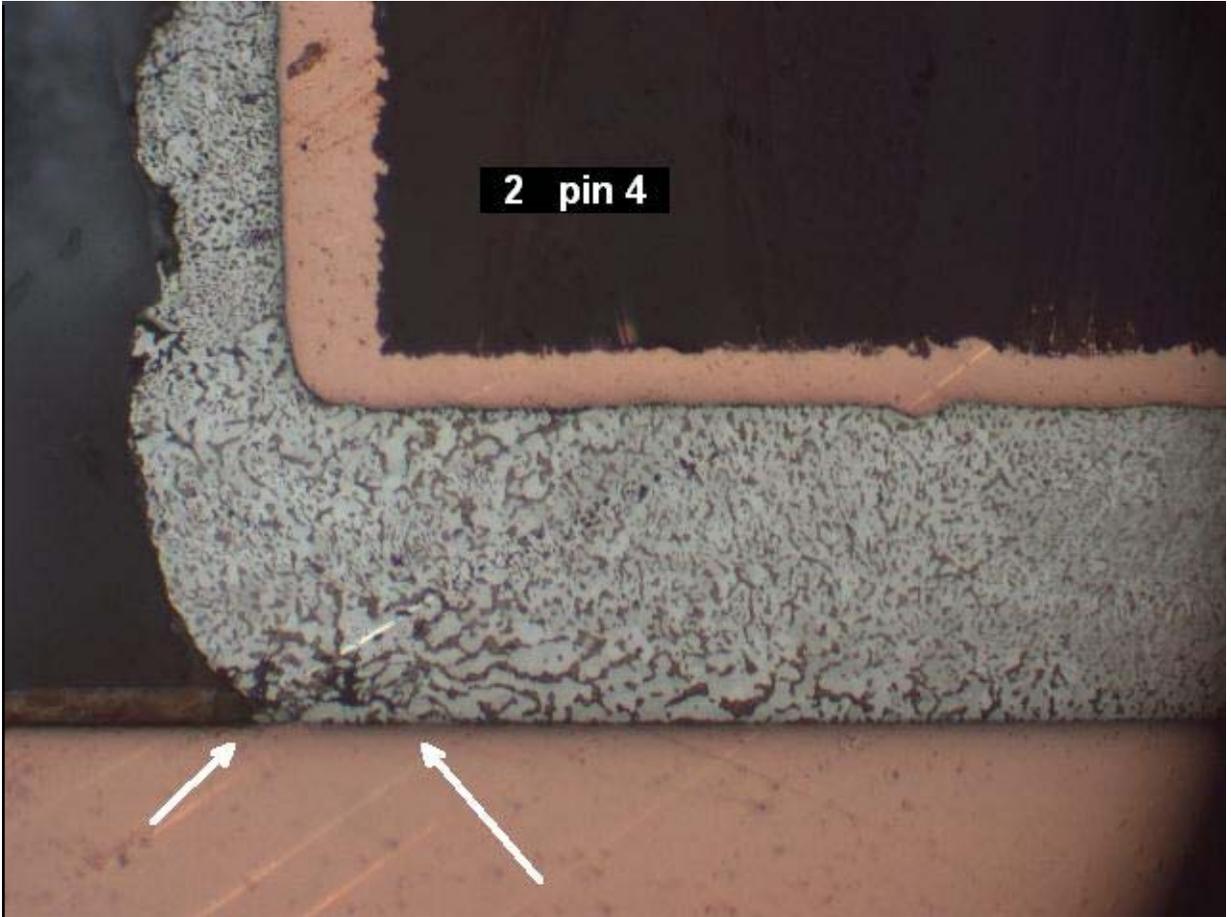
Image 4 White arrows point to cracks in the solder. The top 2 arrows point to a solder crack at the interface with the pin. Note that the solder is coarse and grainy along the pin. The bottom 2 arrows point to a crack in the solder at the top corner of the PCB barrel. This is a higher magnification image of the area shown in image 3.

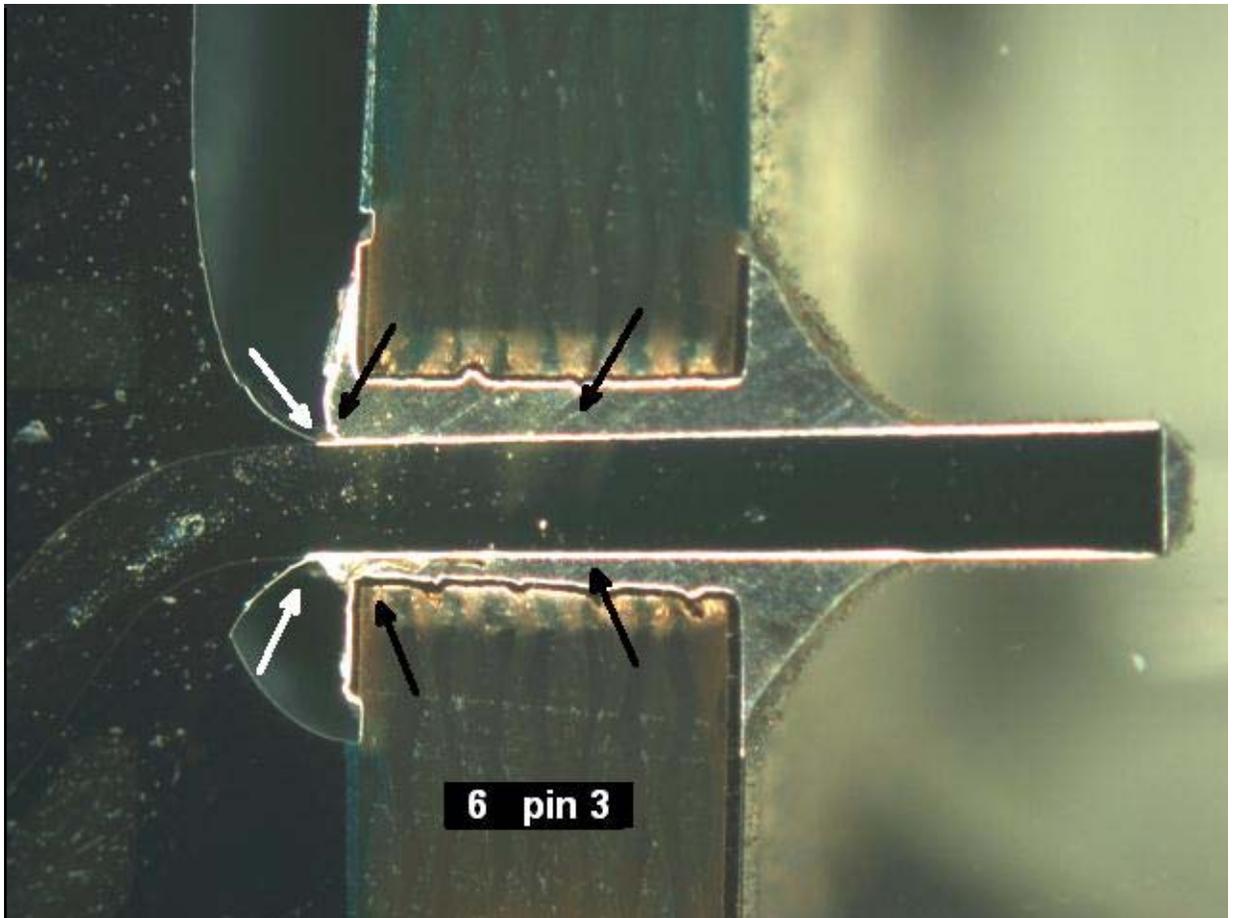
Image 5 The arrows point to a small solder crack in the other side of the cross-sectioned pin.

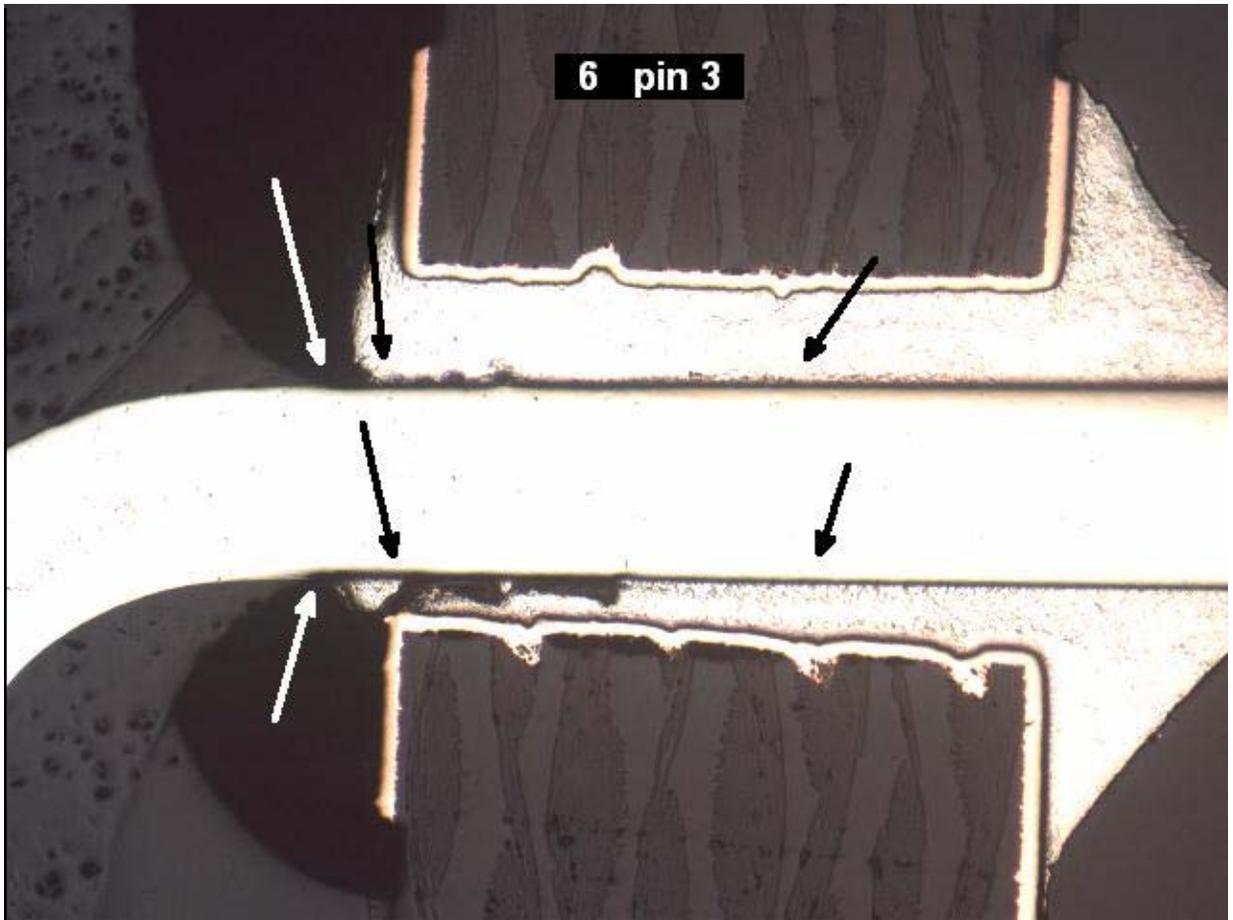
Image 6 through 11 Unit 6 pin 3

Image 6 White arrows point to the edge of the bulk epoxy and white arrows point the crack in the solder joint.

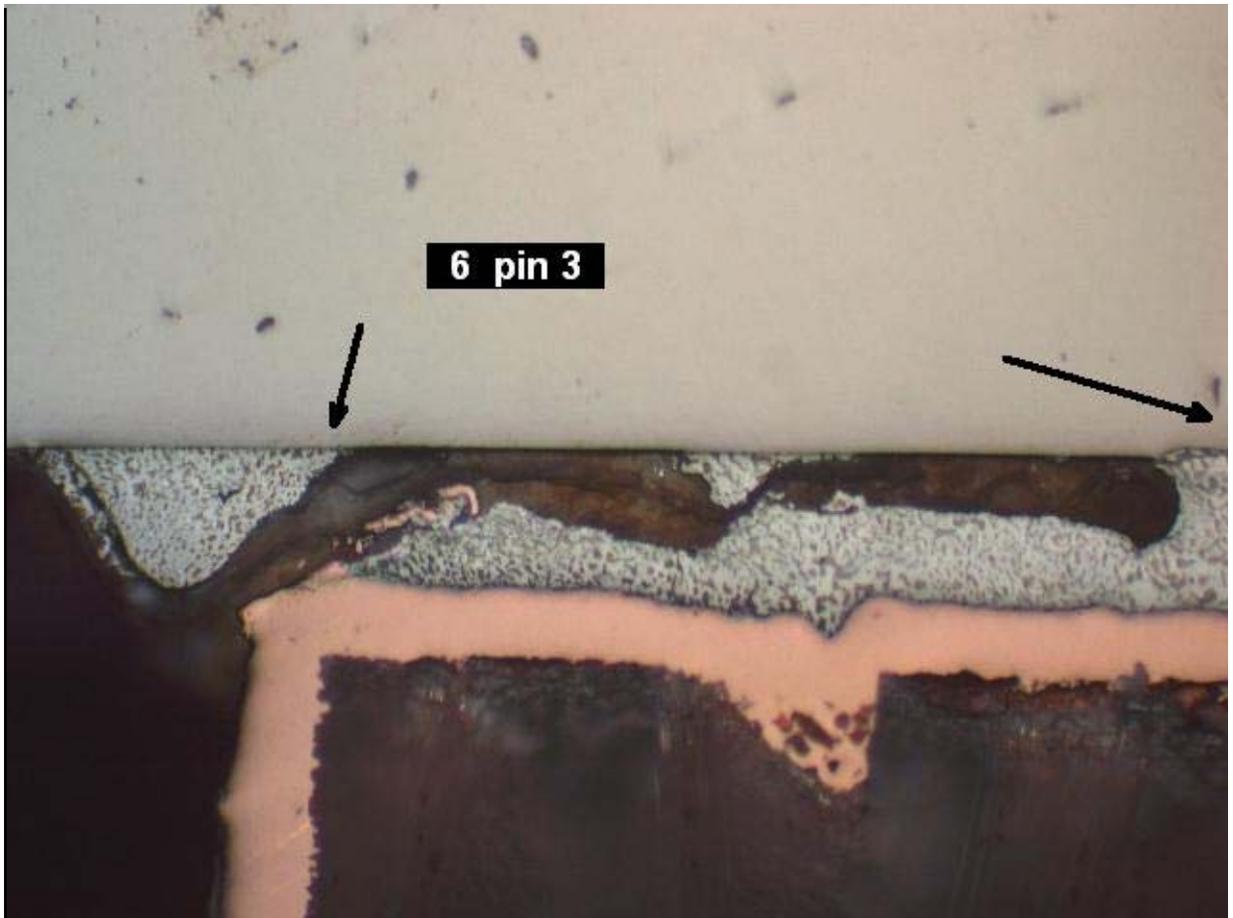
Image 7 Oblique angle lighting highlights the bulk of the epoxy (white arrows). Black arrows point to the solder crack.

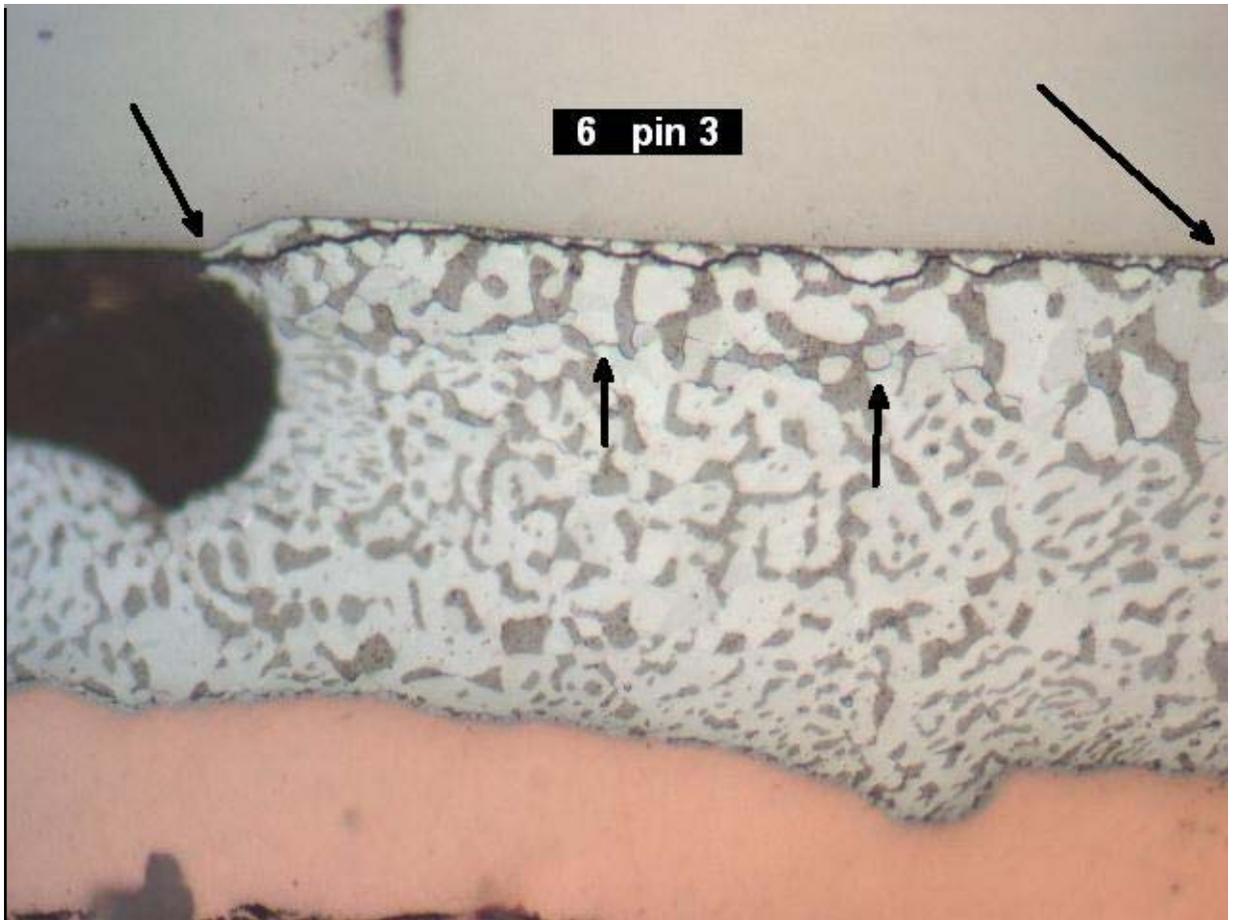
Image 8 Higher magnification image showing gap and solder crack at the top of the hole. This crack extends over 1/2 the depth of the PCB hole. Image 9 shows a fine crack extending beyond the large gap. While some solder is cracked around the top of the hole the gaps may also include solder voids.

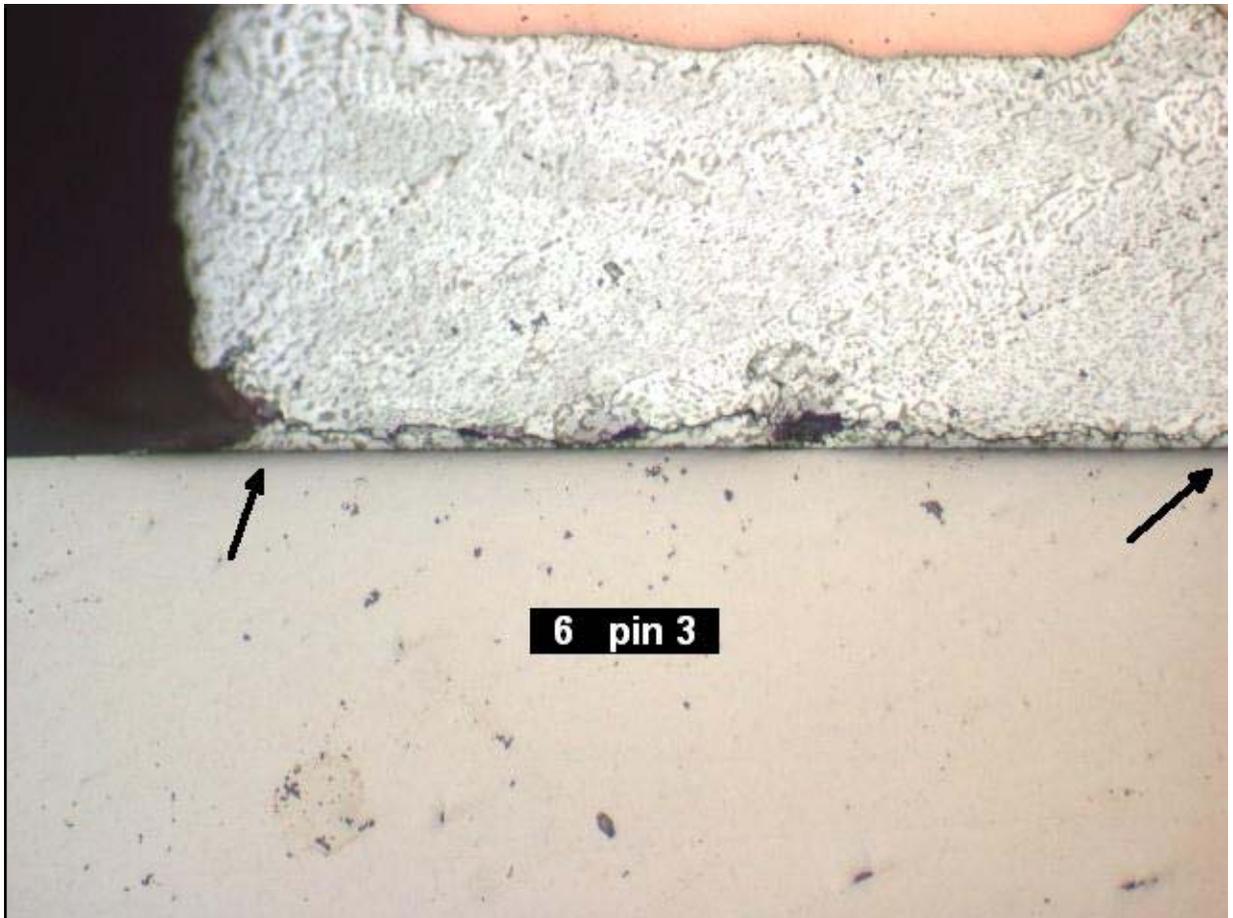
Image 9 Higher magnification image of the crack extending from the bottom of the gap shown in image 8.

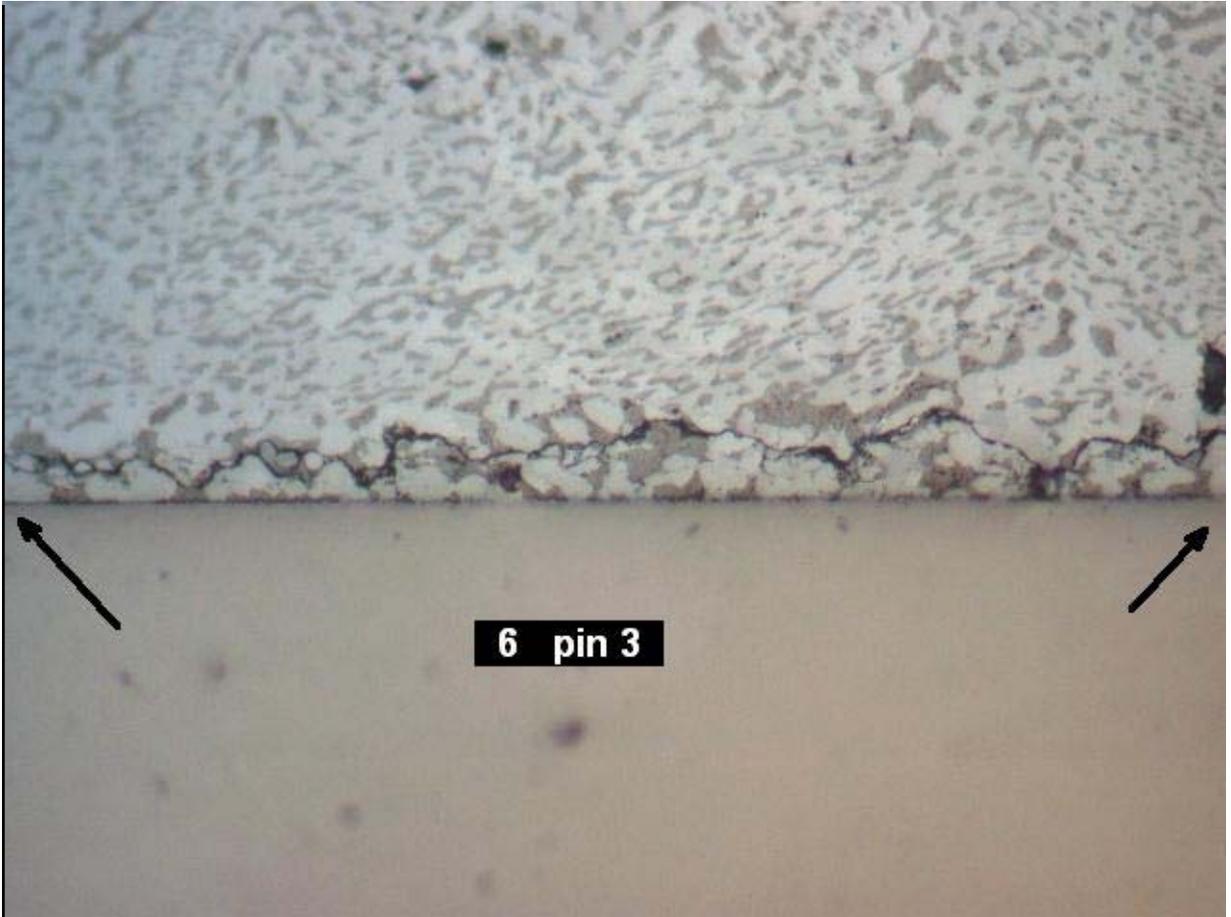
Image 10 The arrows point to a small solder crack in the other side of the cross-sectioned pin.

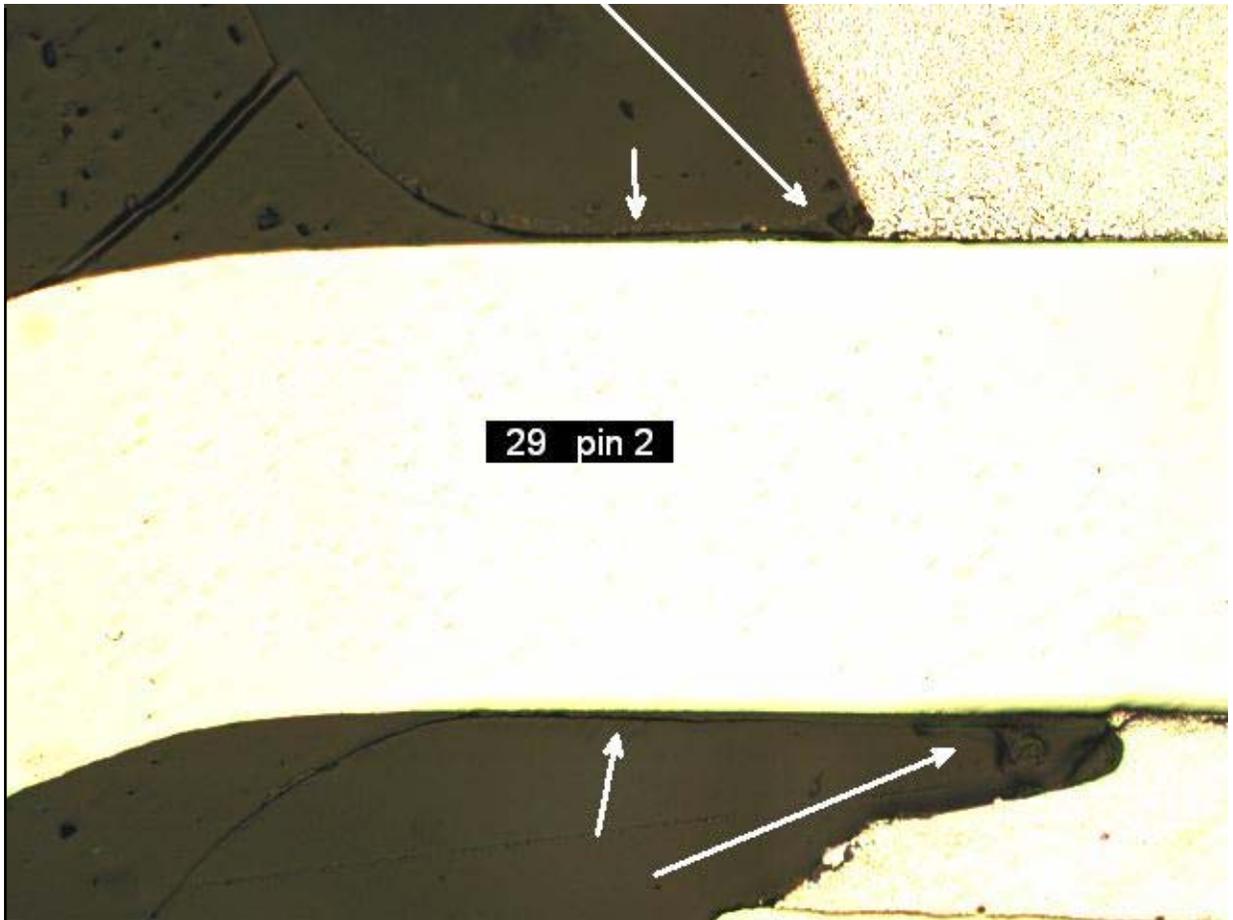
Image 12 through 18 Unit 29 pin 2

Image 12 White arrows point to the edge of the bulk epoxy and black arrows point the crack in the solder joint.

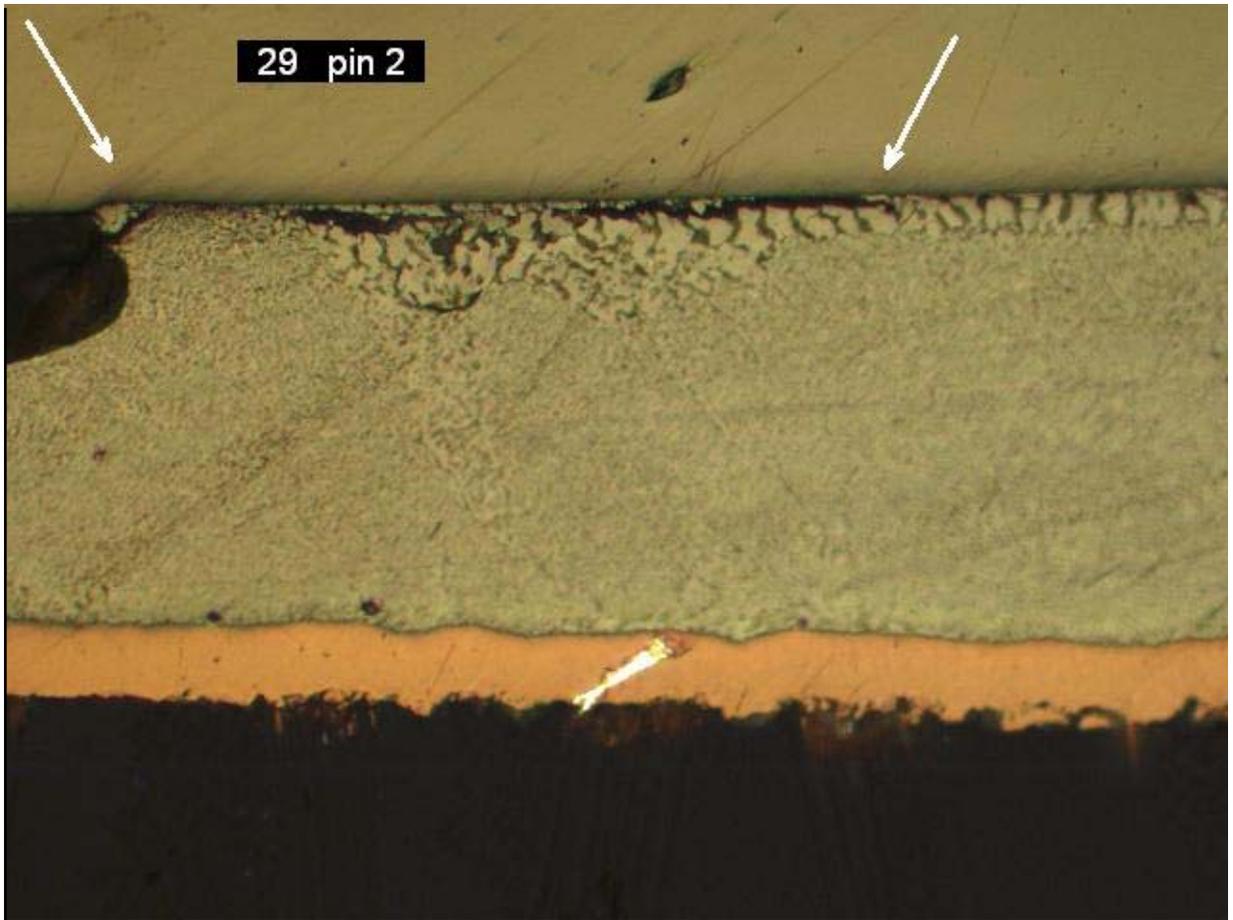
Image 16 Cross-section image showing the location of the solder crack (white arrows). Note how coarse grained the solder is next to the bottom side of the pin in this view..

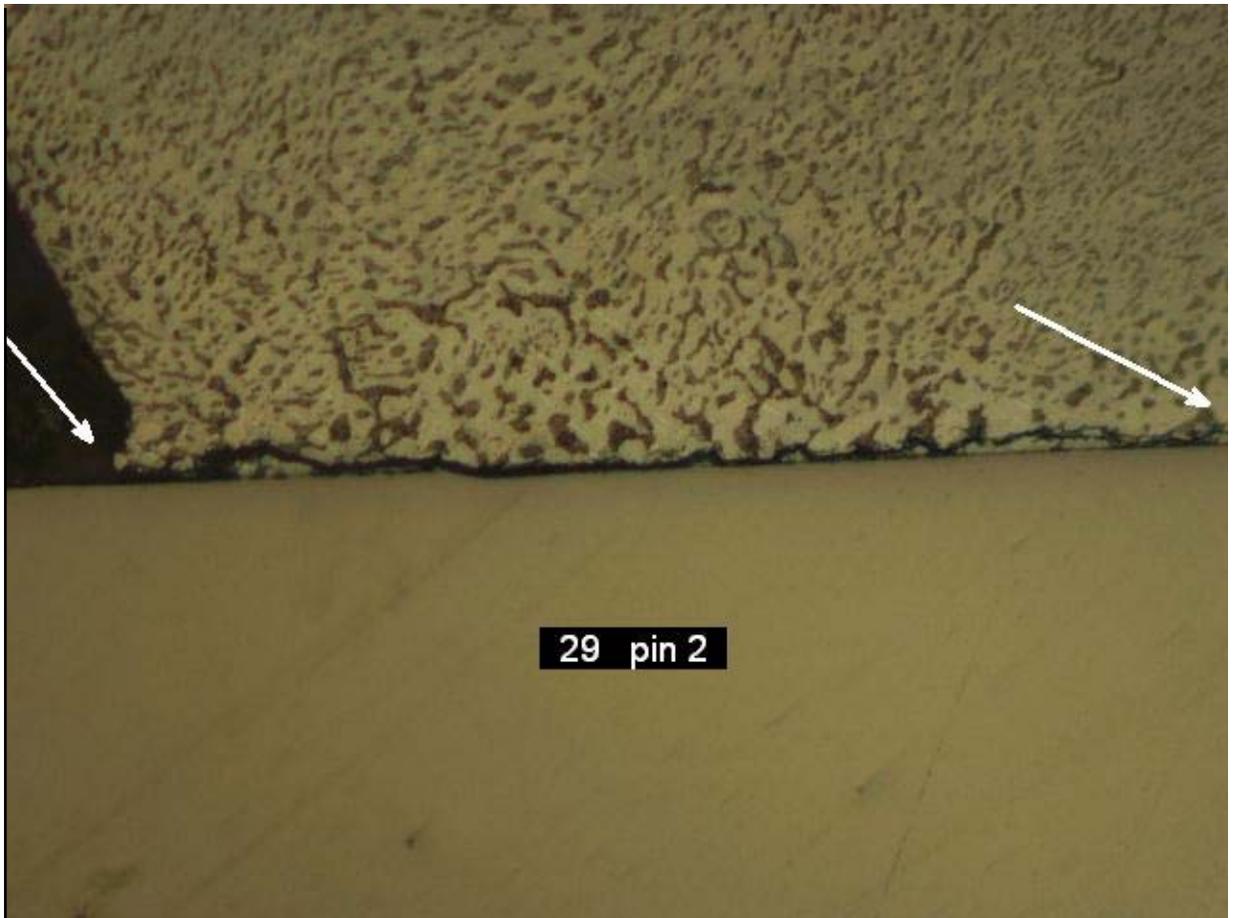
Image 17 Higher magnification image showing the crack on one side of the cross-sectioned pin.

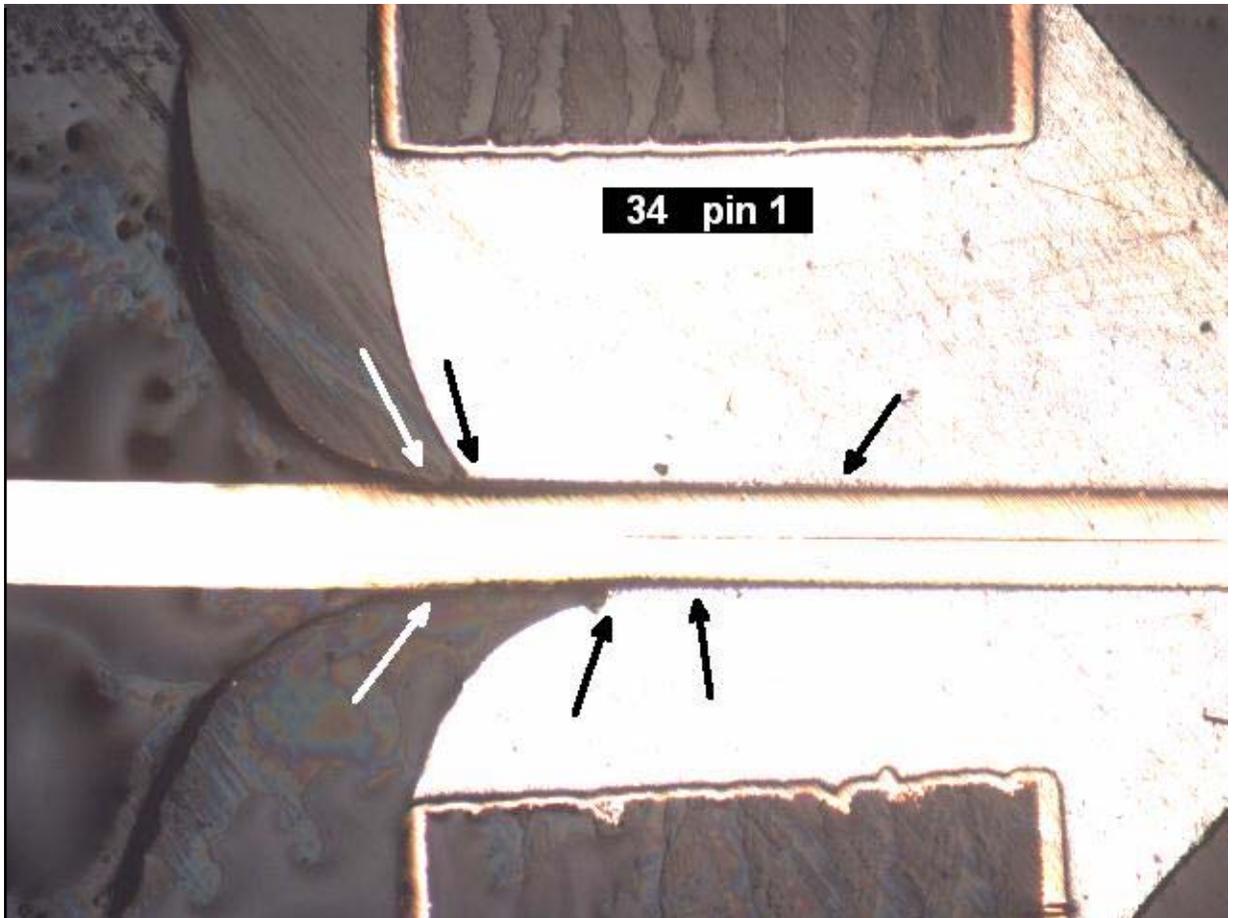
Image 19 through 21 Unit 34 pin 1

Image 19 White arrows point to the edge of the bulk epoxy and black arrows point the crack in the solder joint

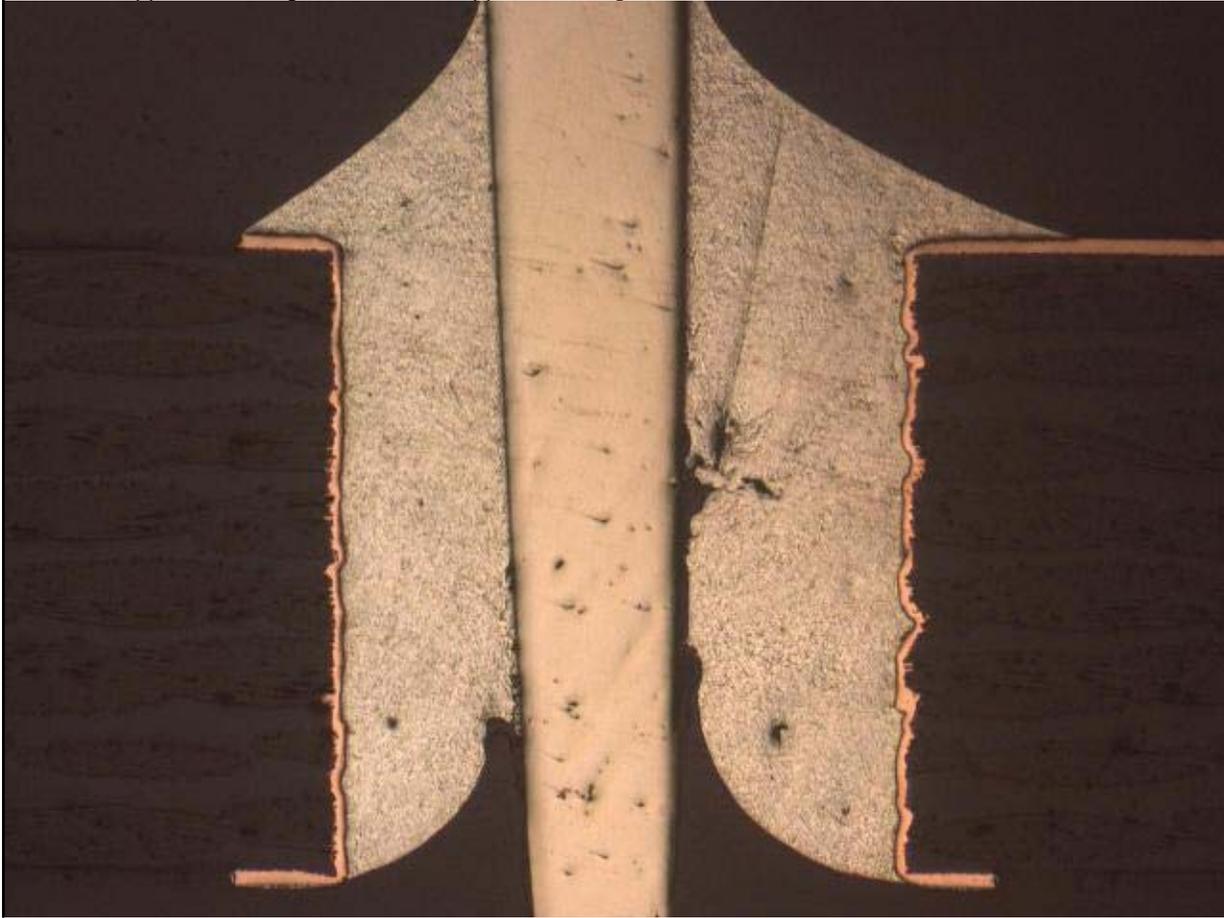
2 - Cross section photo of pin 1 of K220. There appears to be cracking at both sides of the pin on the bottom of the solder joint. There also appear to be slight folds in the copper on the right side.

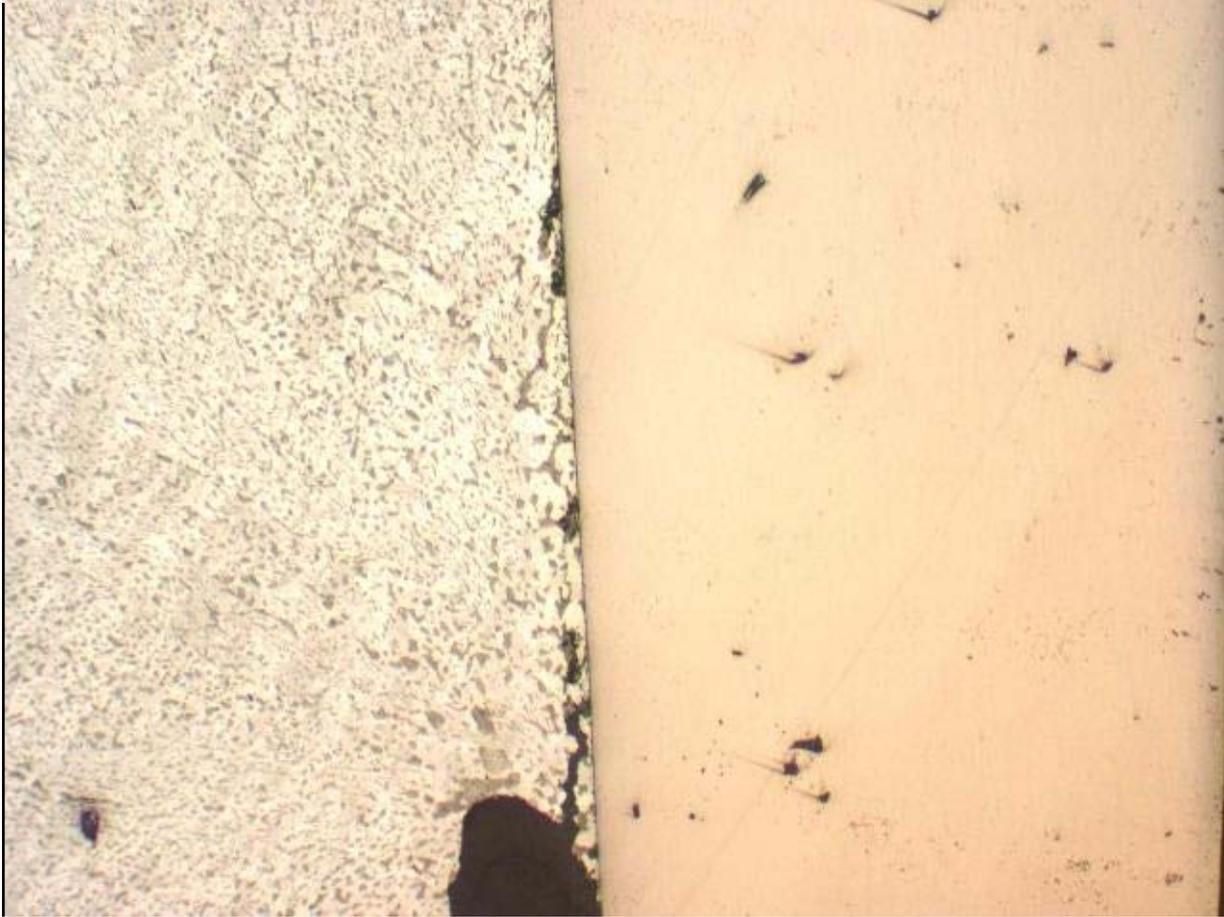
3 - Higher magnification image of the cracking on the left side of the pin.

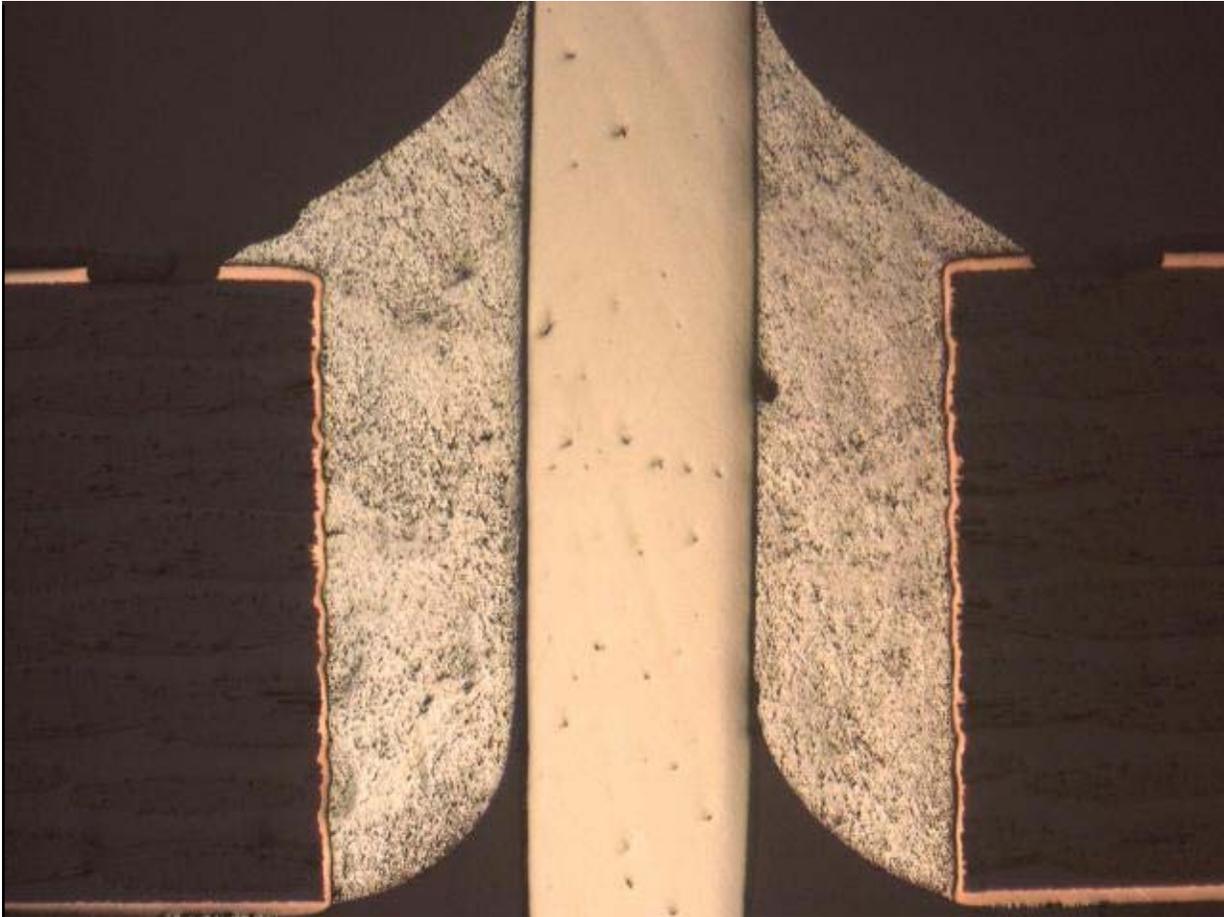
10 - Cross section image of pin 3 from K220. There appeared to be minor cracking on the left side of the pin.

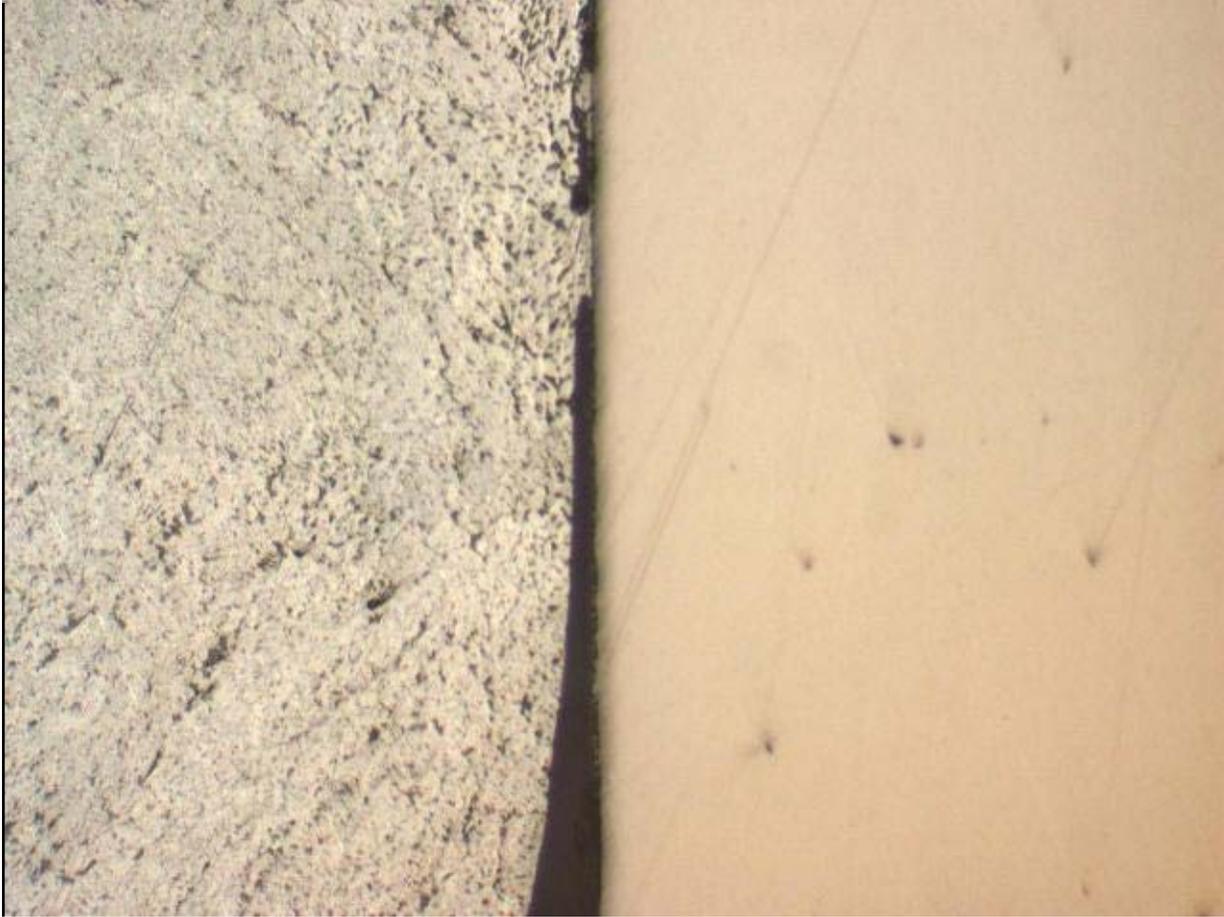
11 - Higher magnification image of the left side of the pin. Note the small cracks at the top of the image.

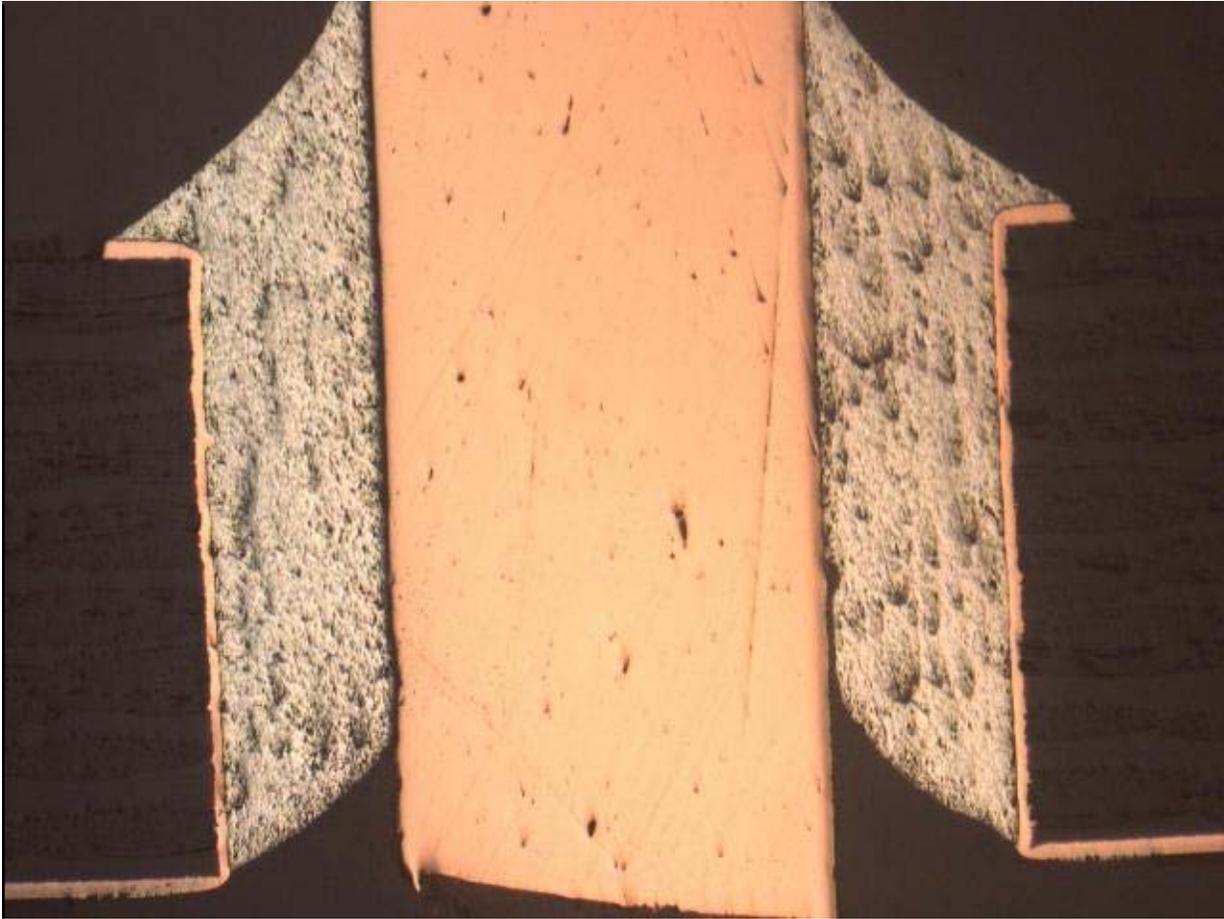
14 - Cross section image of pin 4 from K220. Cracking was visible on the right side of the pin.

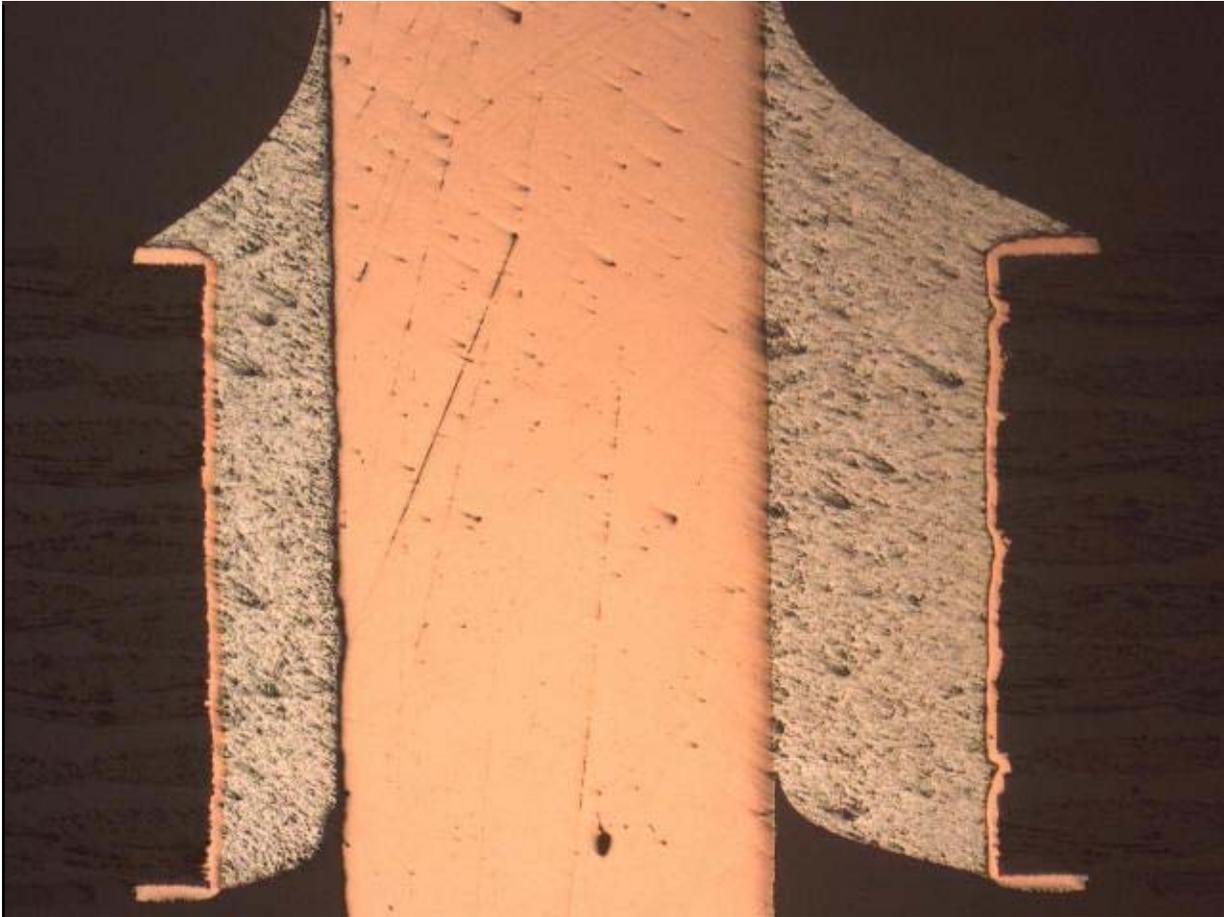
18 - Cross section image of pin 5 from K220. Some cracking was seen on the right side of the pin. Note that there are some folds in the via wall on the right side of the image.
