PE08-066

FORD

APPENDIX G

ENGINEERING REVIEW

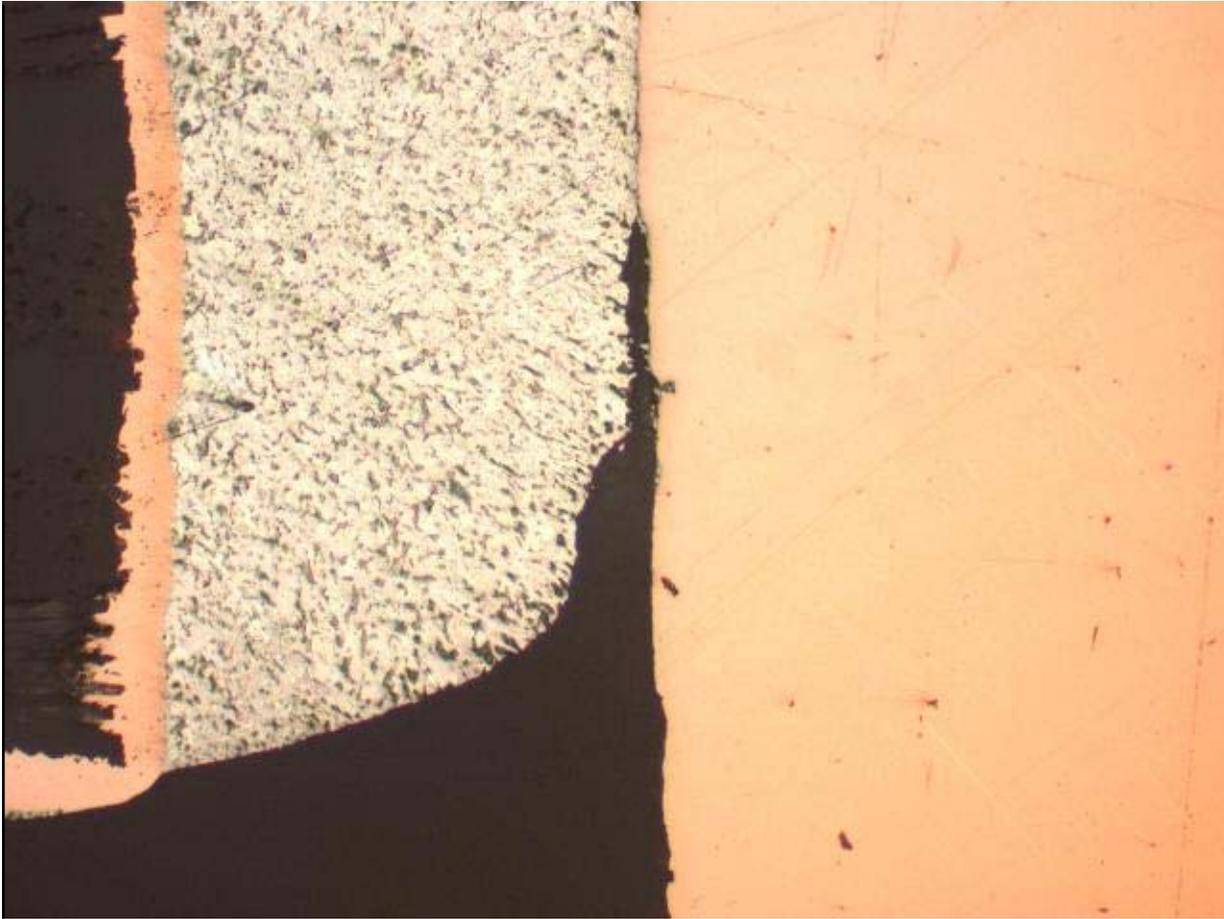
19 - Higher magnification image of the left side of the pin. Some cracking was visible.

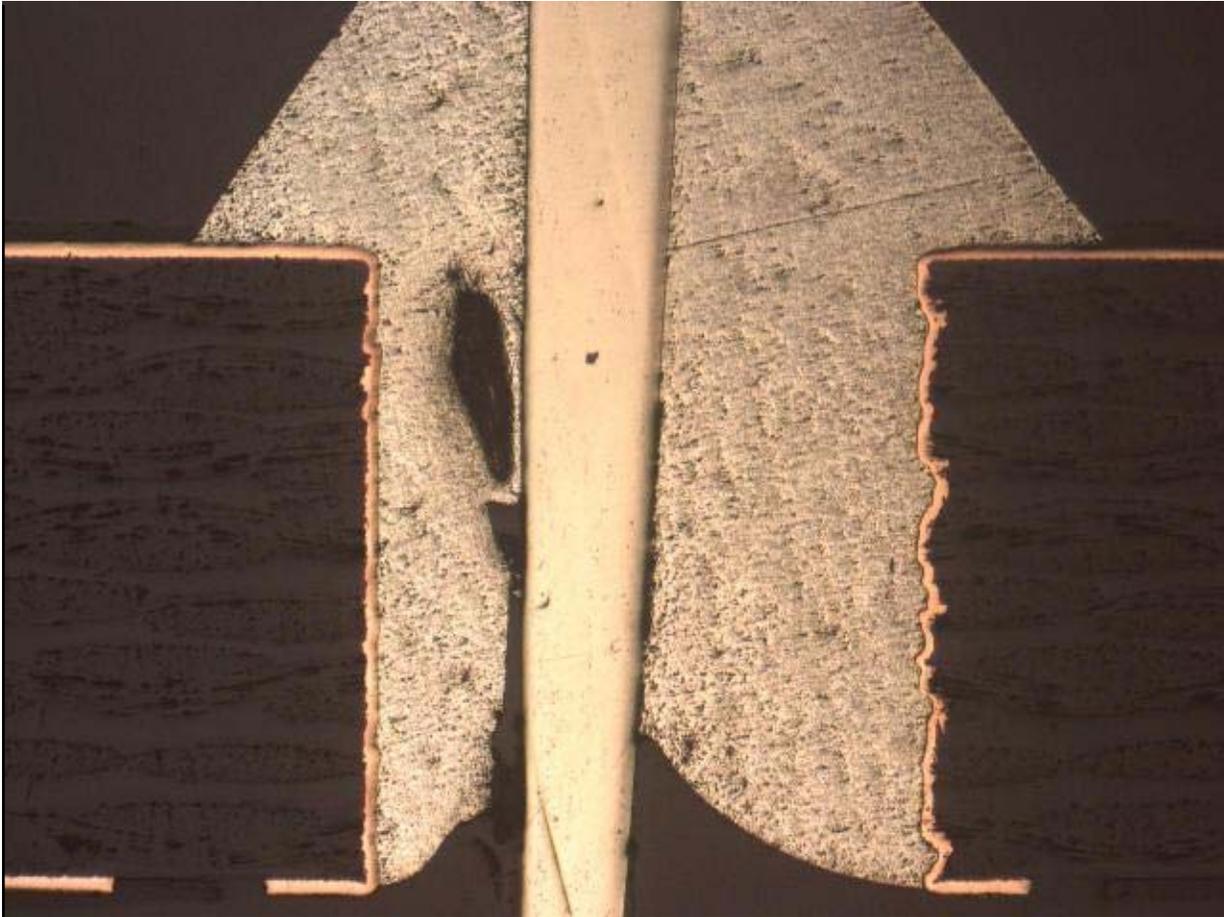
22 - Cross section image of pin 1 from K221. A large void was visible on the left side of the pin and cracking was visible on the right side. There also appeared to be many folds on the right side of the image.

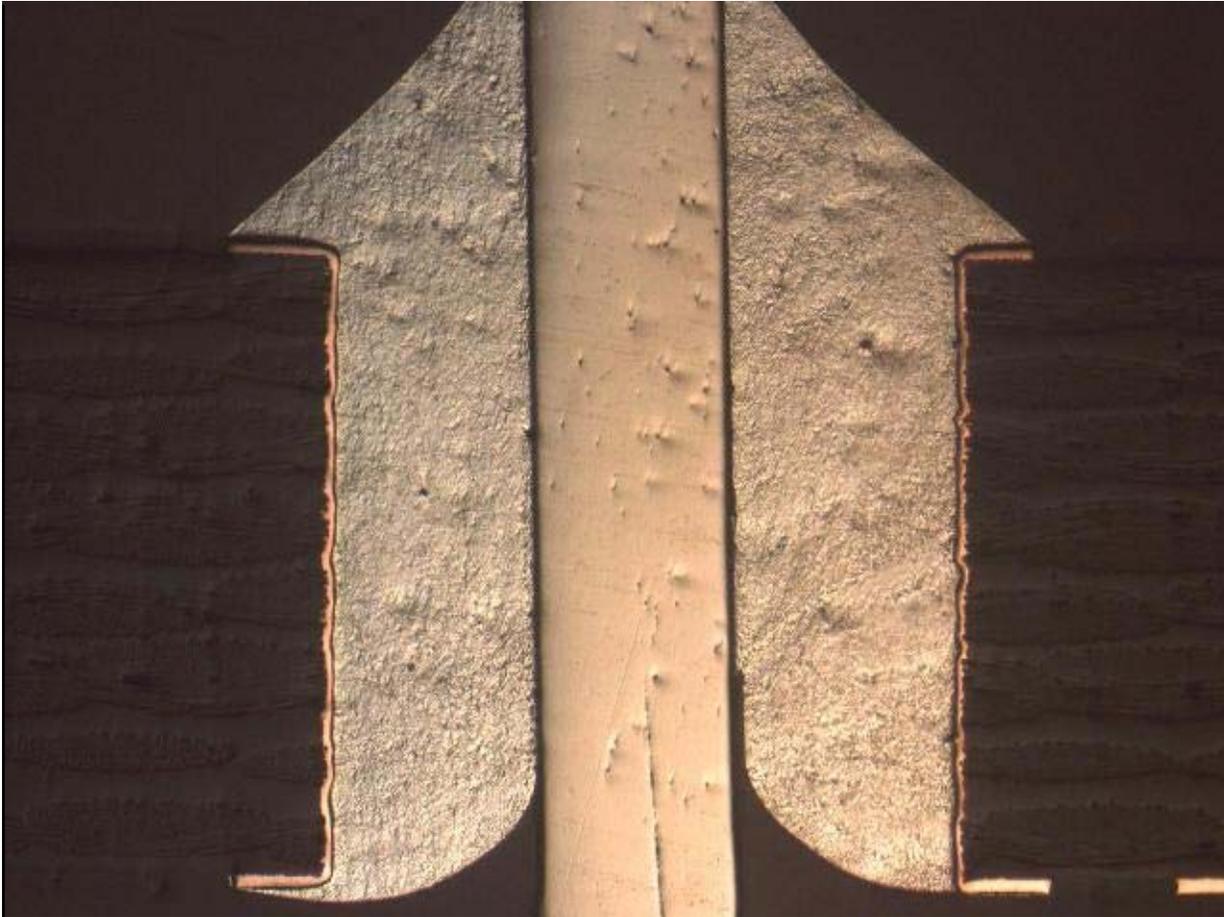
30 - Cross section image of pin 3 from K221. A small crack was found on the right side of the pin.

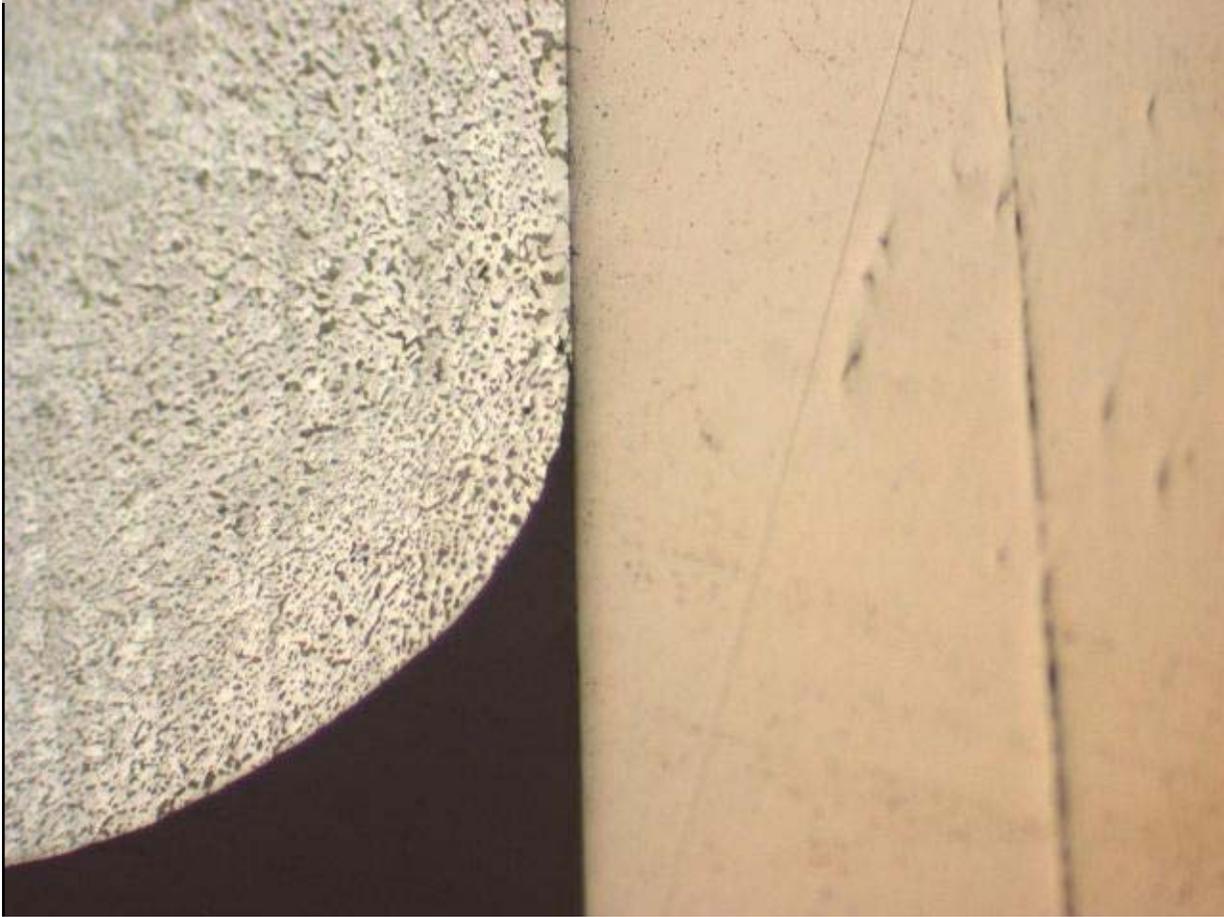
32 - Higher magnification image of the right side of the pin. Note the small crack.

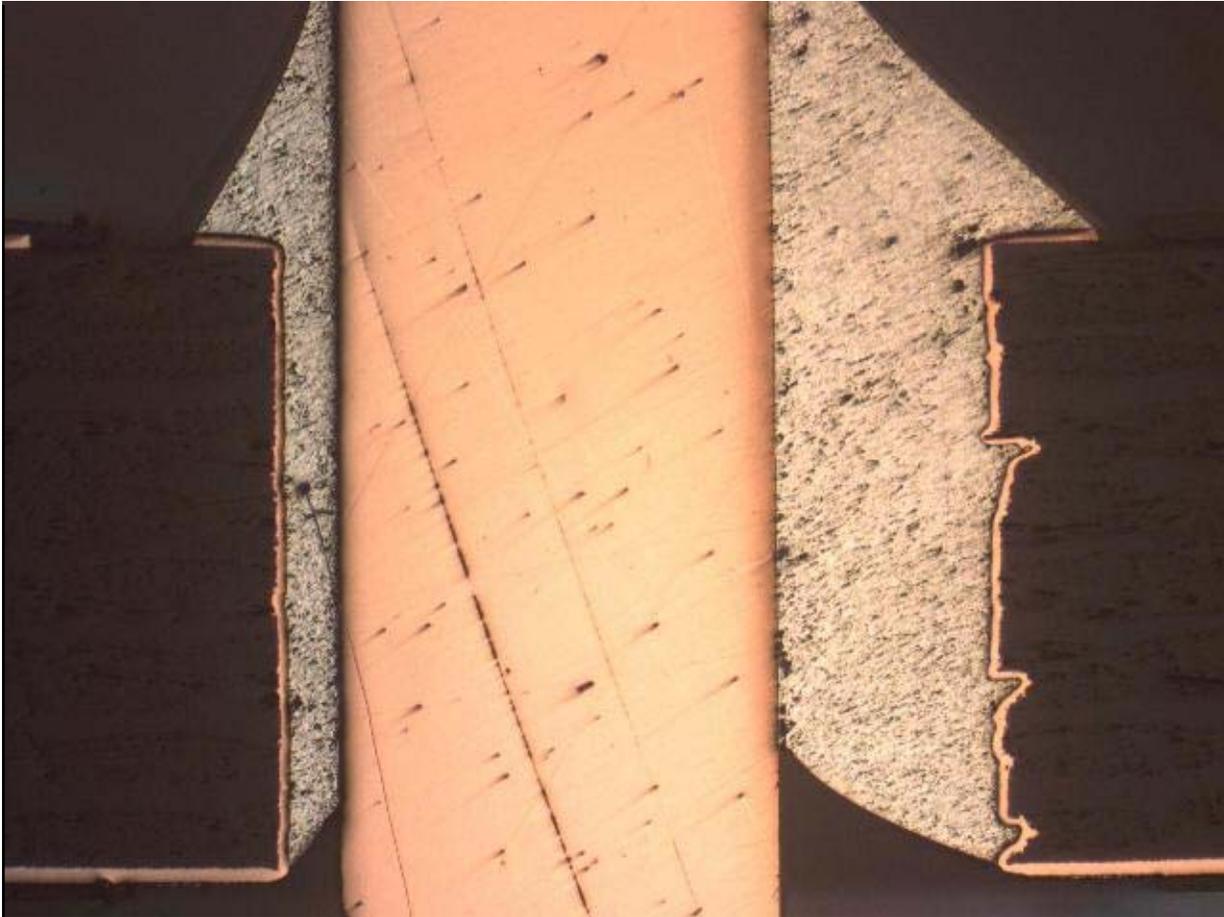
34 - Cross section image of pin 4 from K221. Cracking was visible on the right side of the pin. Sever copper folds are visible on the right side of the via.

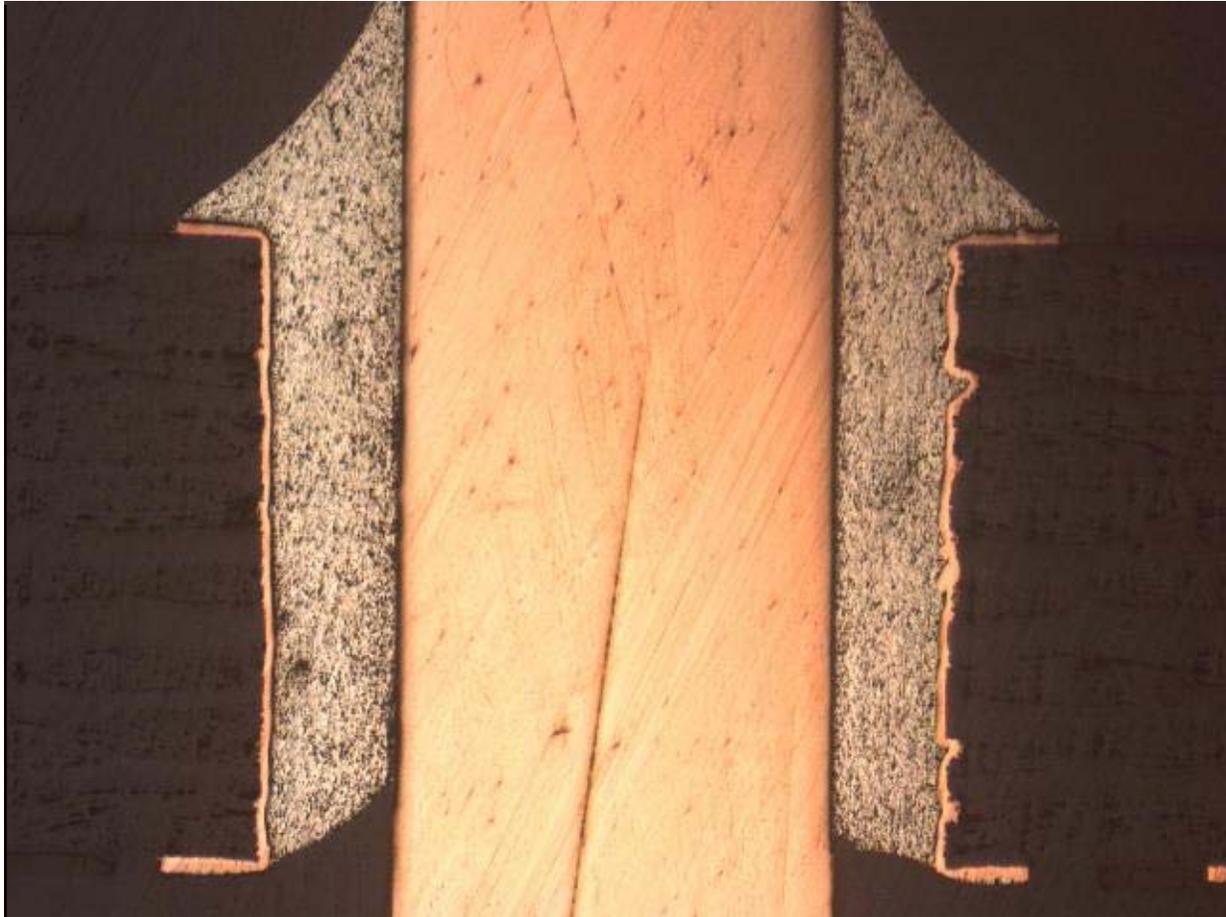
54 - Cross section image of pin 4 from K222. Severe folds are visible in the via wall on the right side. Cracking is visible on the left side of the pin.

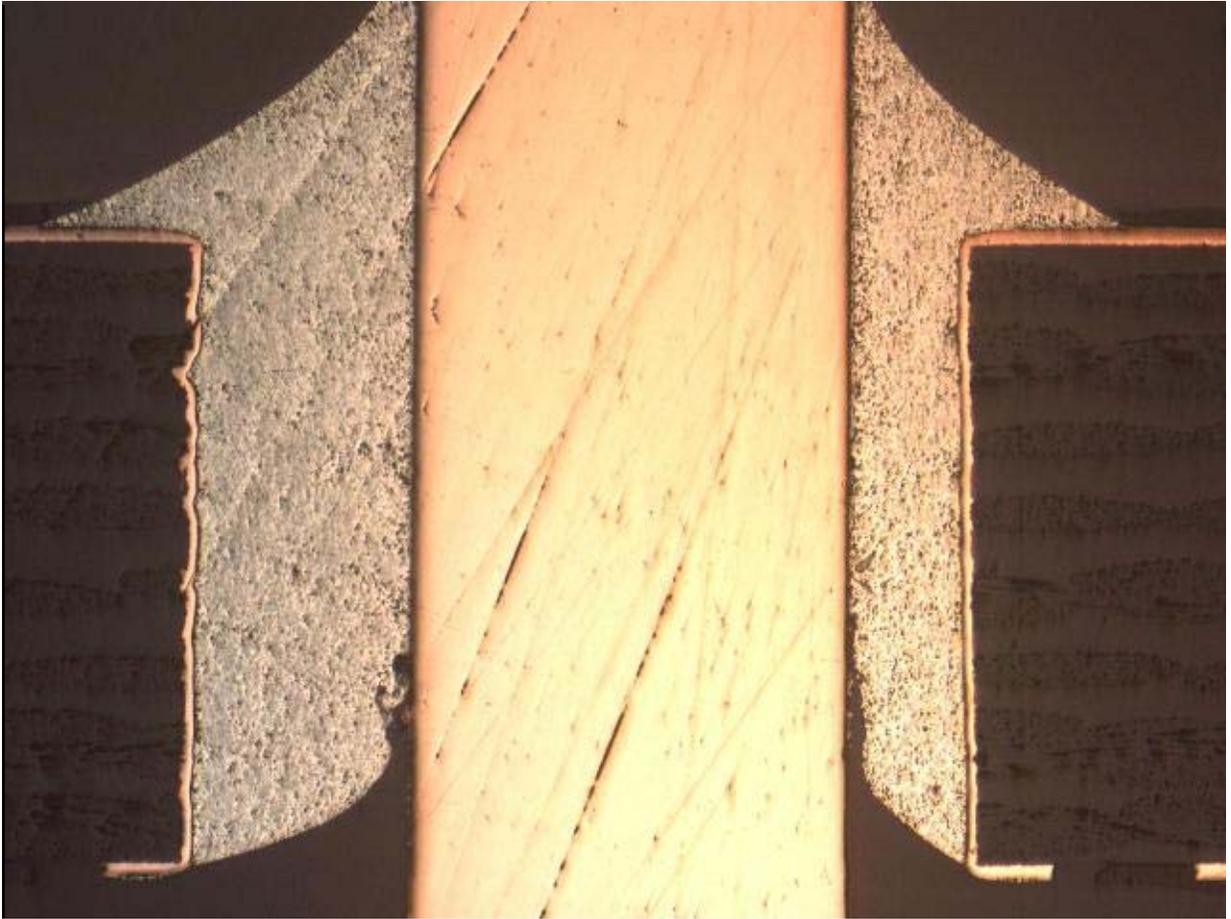
58 - Cross section image of pin 5 from K222. Cracking was visible on both sides of the pin.
