PE08-066

FORD

APPENDIX G

ENGINEERING REVIEW

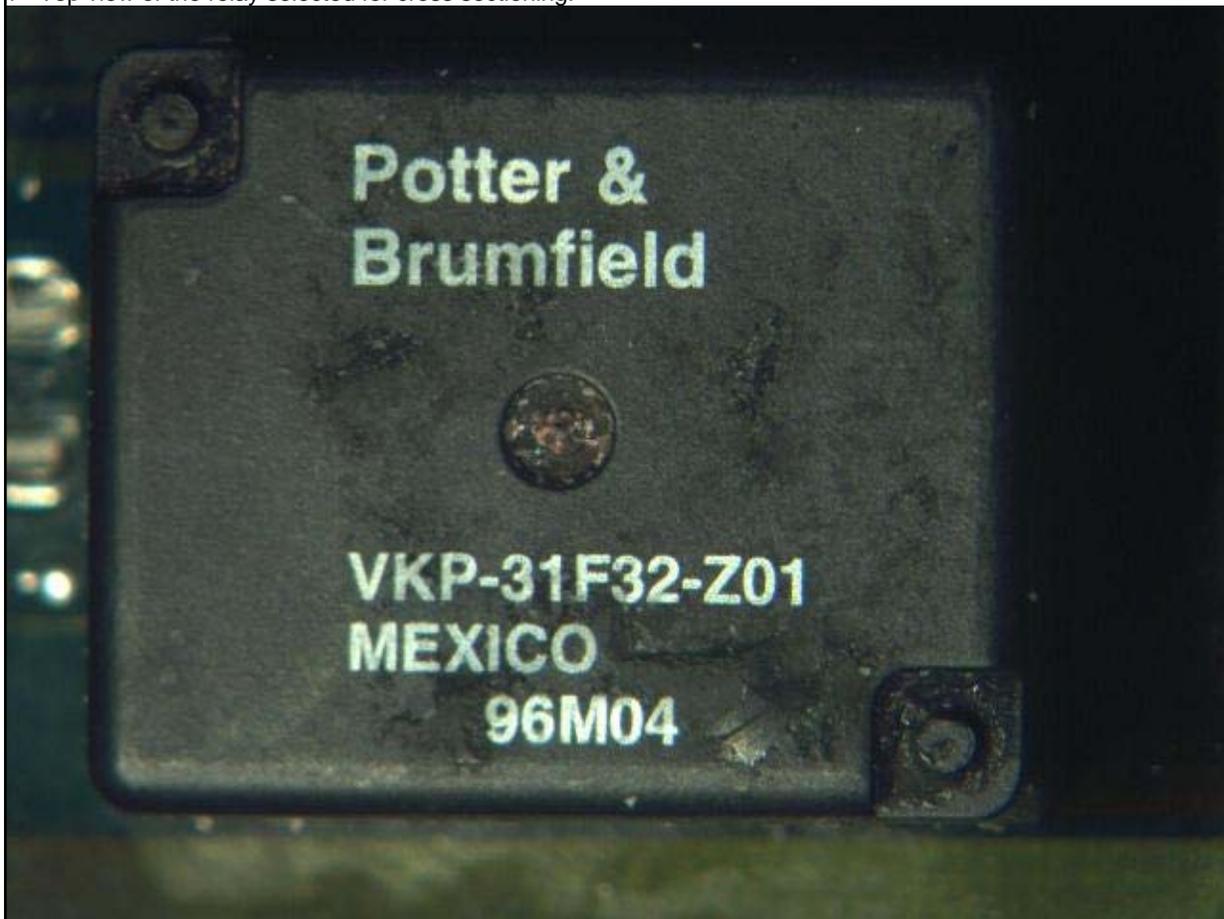
1 - Top view of the relay selected for cross sectioning.

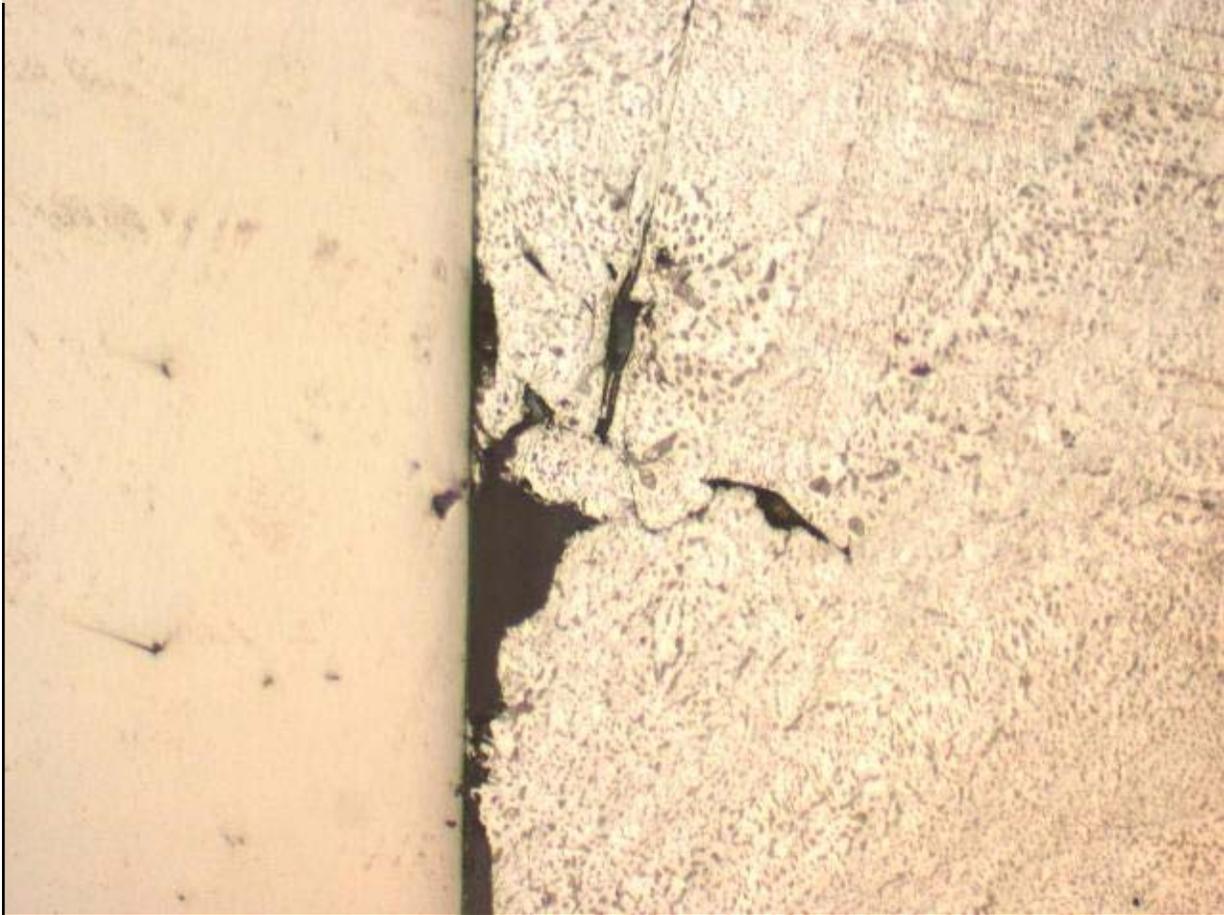
5 - Optical photo of pin 2 from K220. There did not appear to be any signs of cracking. The solder is shiny.

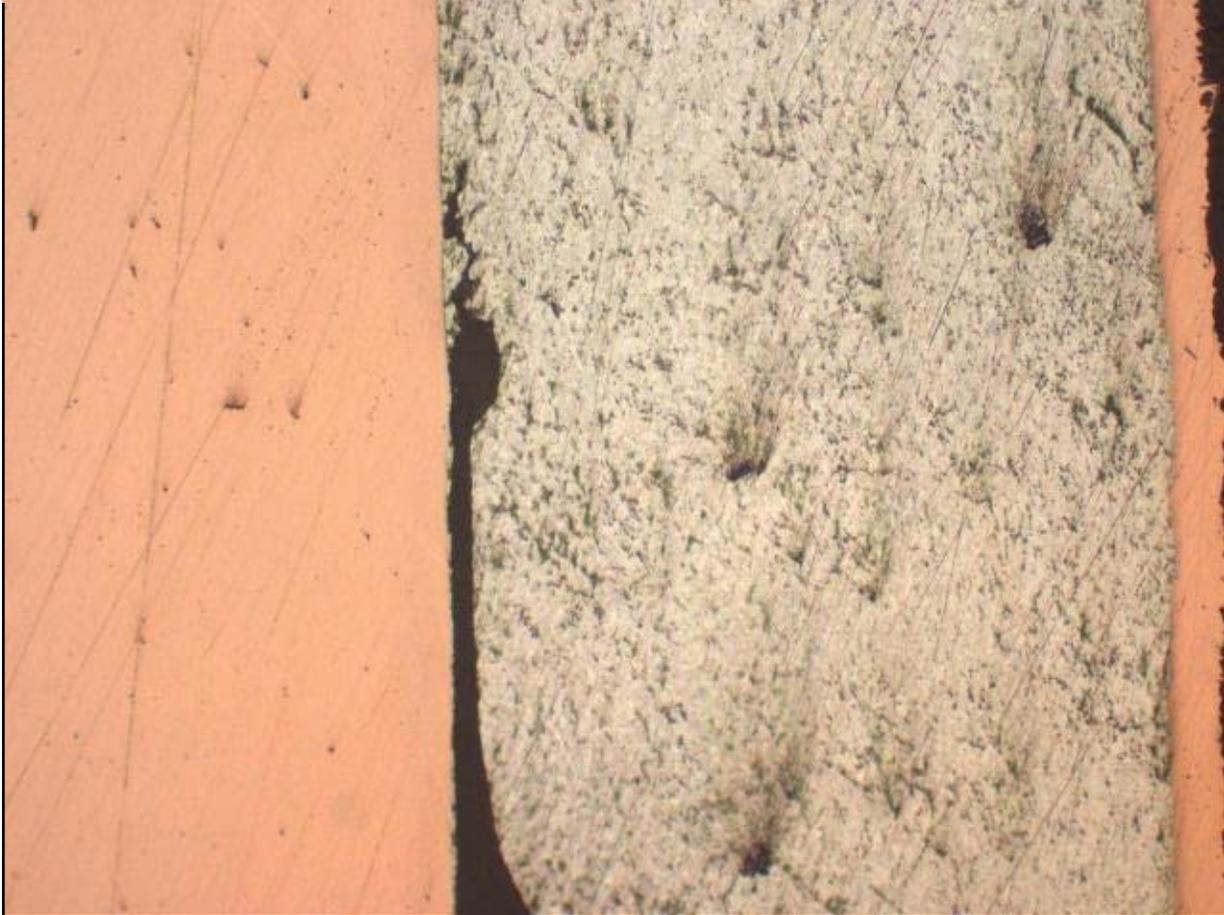
17 - Optical image of pin 5 from K220. No visible signs of cracking were seen. The solder appeared to be shiny.

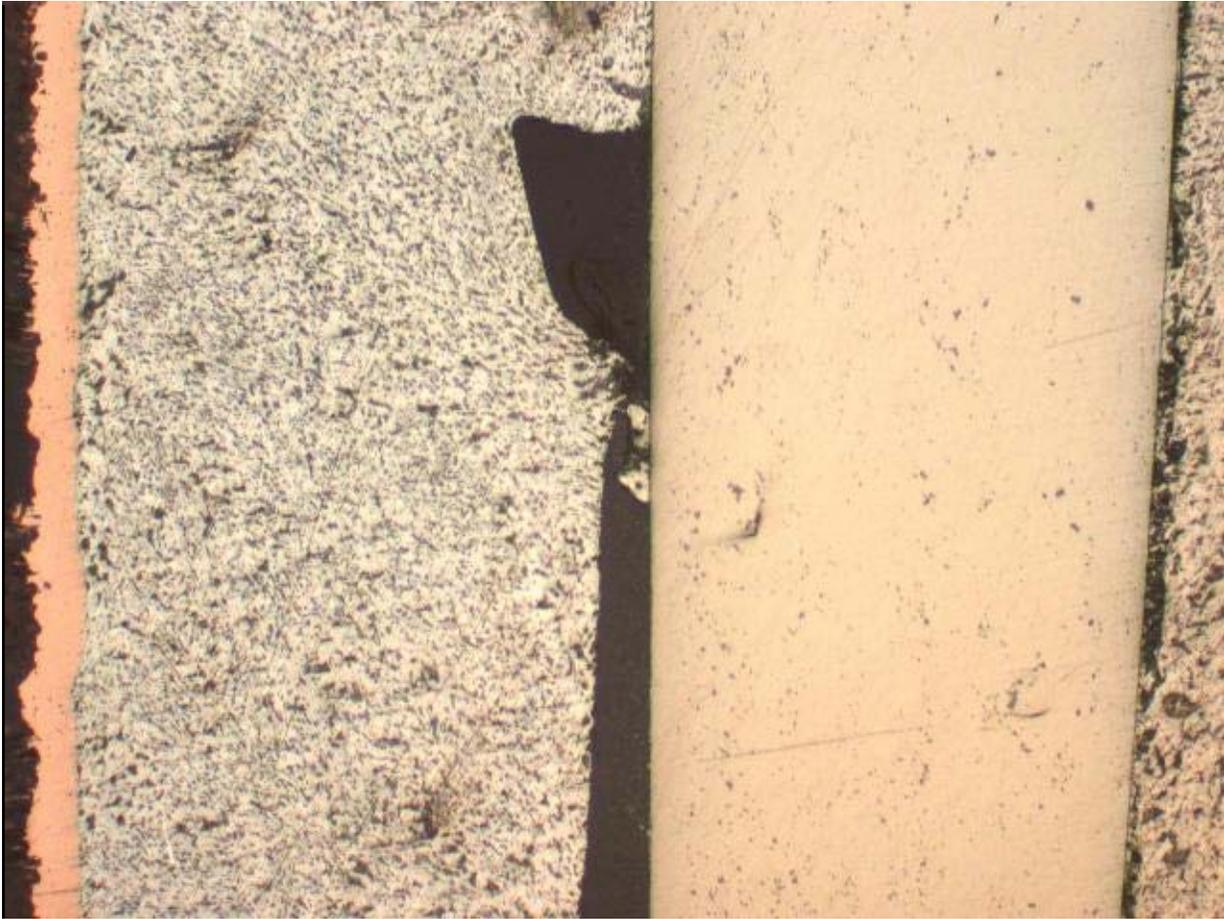
24 - Higher magnification image of the cracking on the right side of the pin.

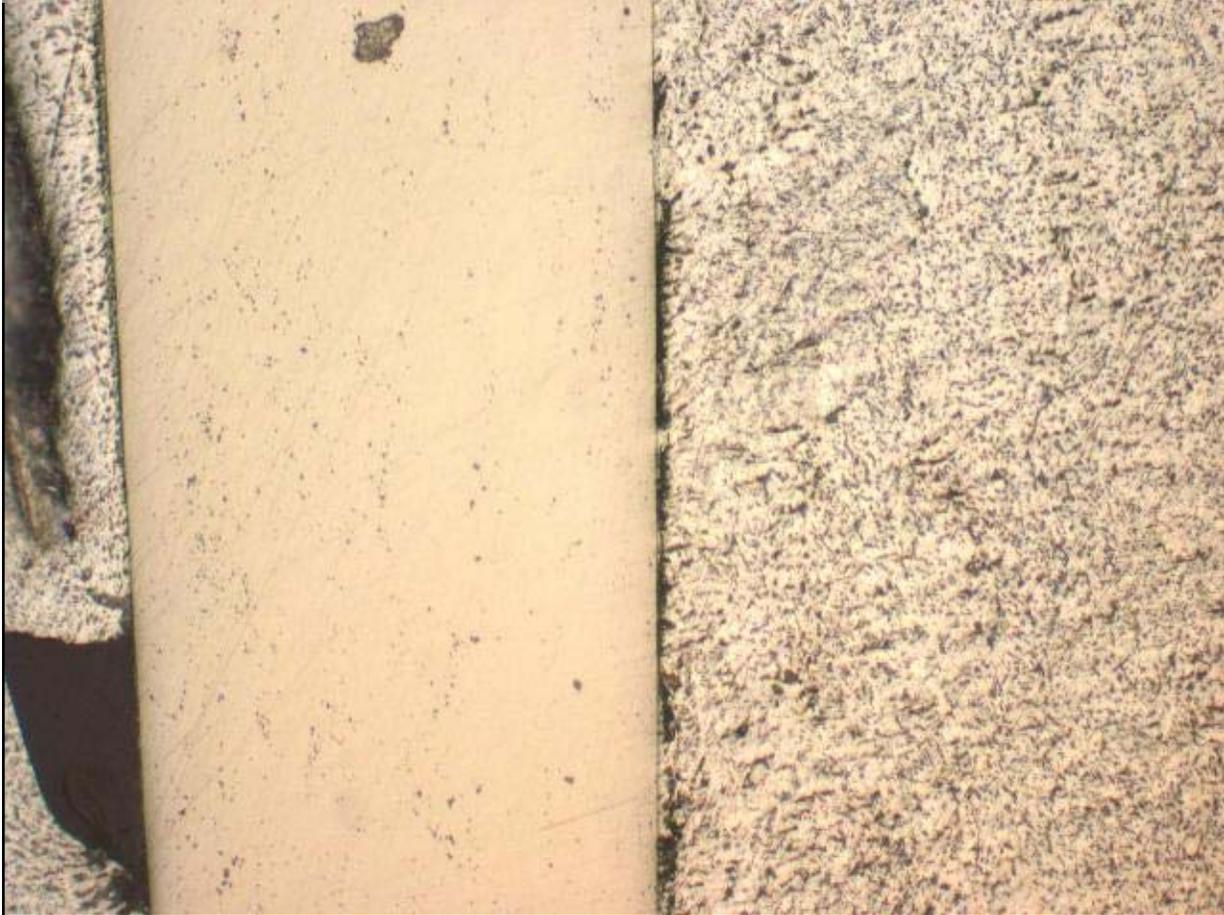
25 - Optical image of pin 2 from K221. No signs of cracking were visible. The solder appeared to be grainy toward the edges of the via.

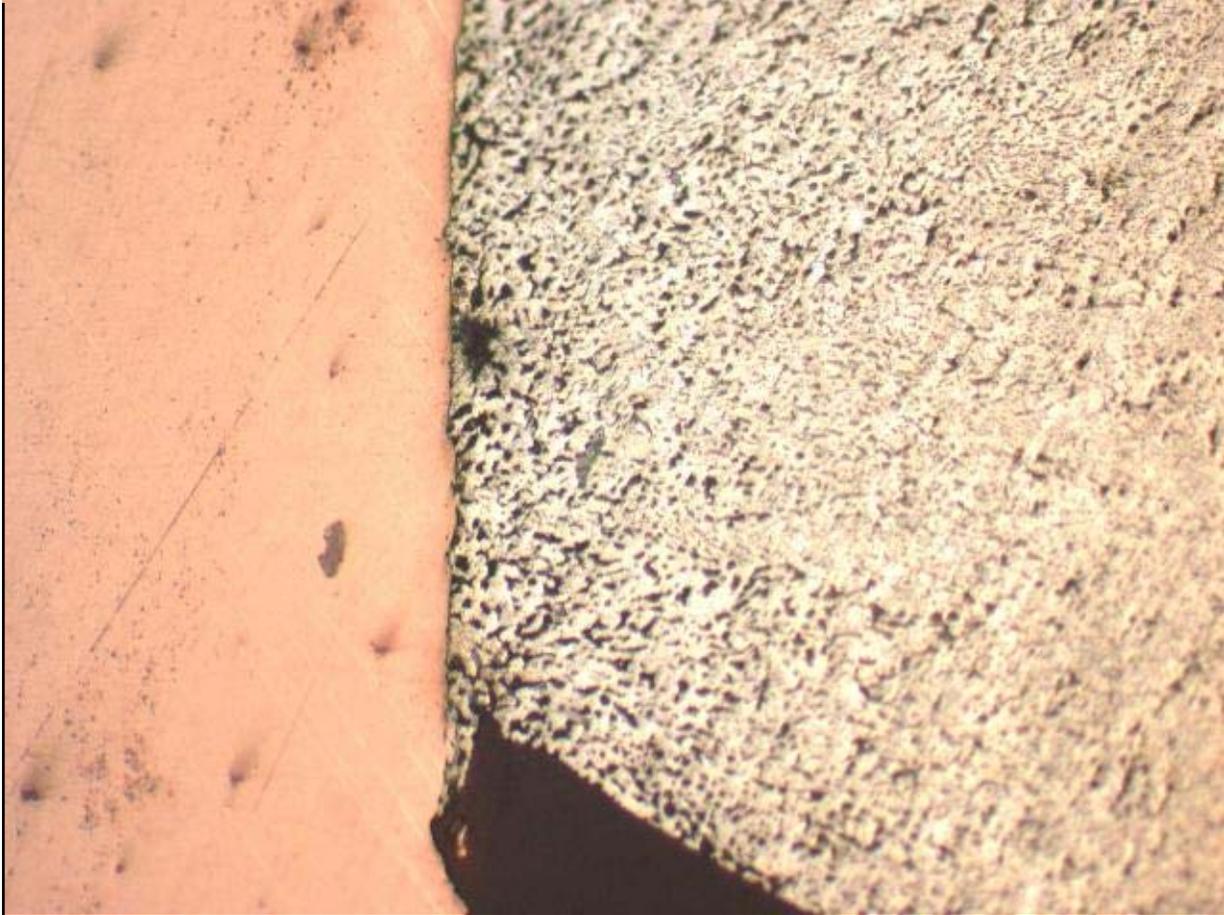
41 - Optical photo of pin 1 from K222. No signs of cracking were visible. The solder appeared shiny.

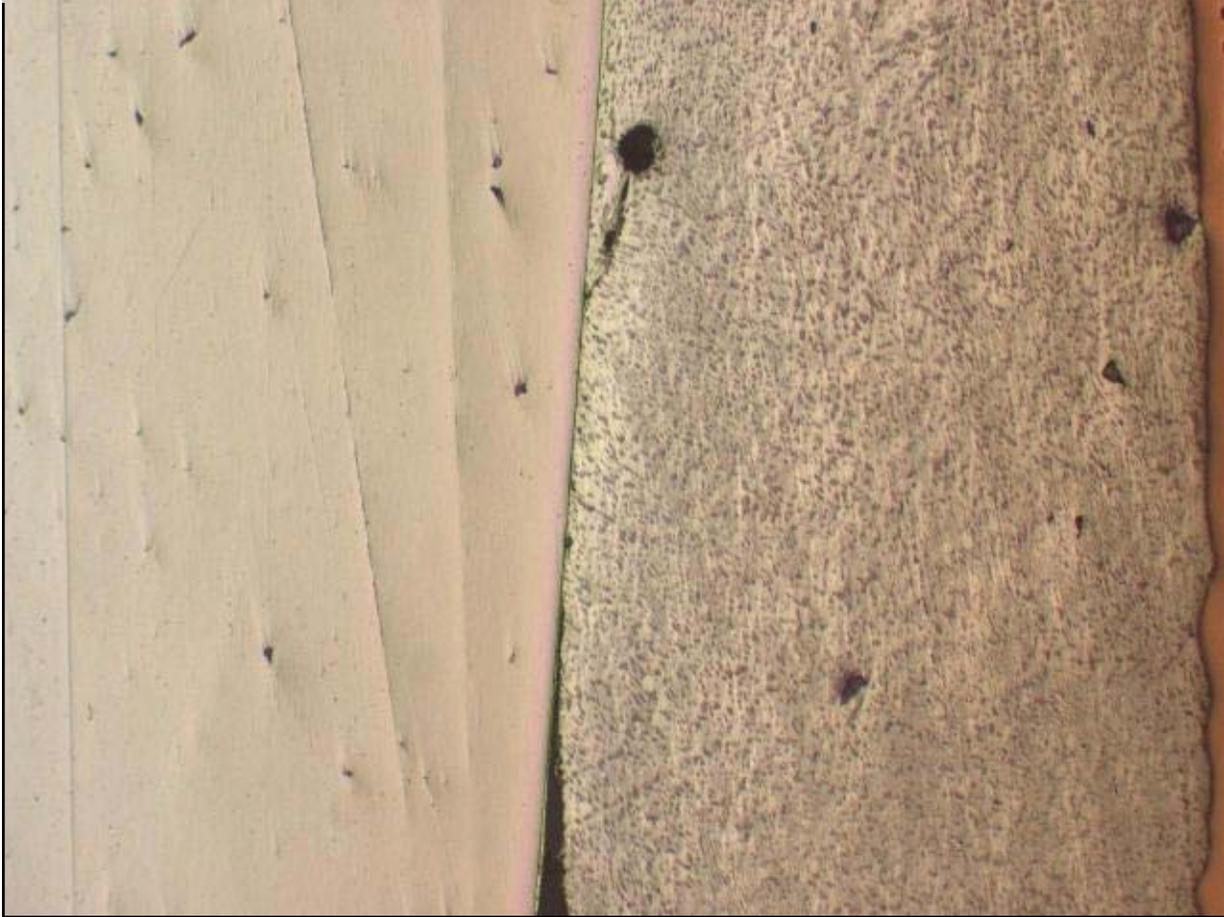
45 - Optical image of pin 2 from K222. No signs of cracking were visible. The solder appears shiny.

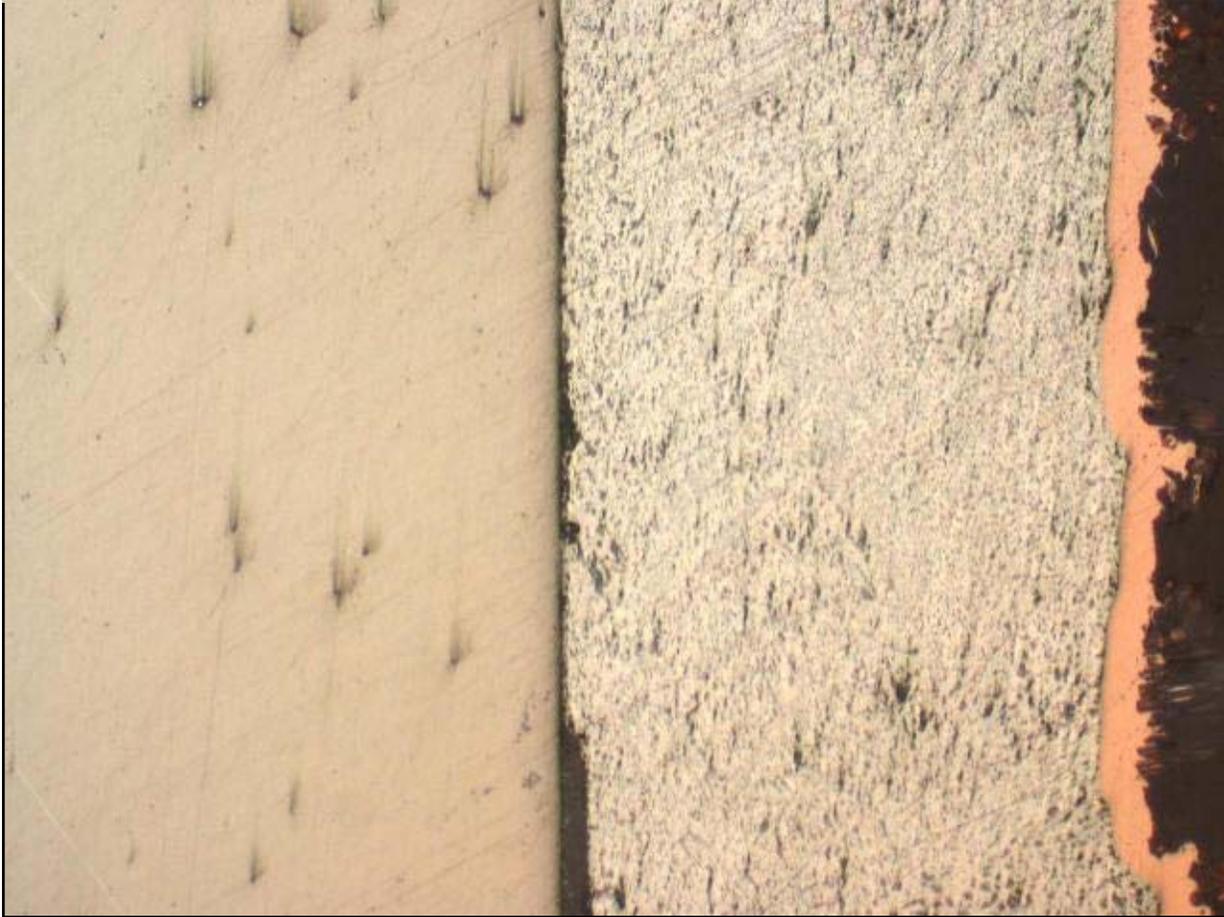
53 - Optical image of pin 4 from K222. No signs of cracking were visible. The solder appeared grainy.

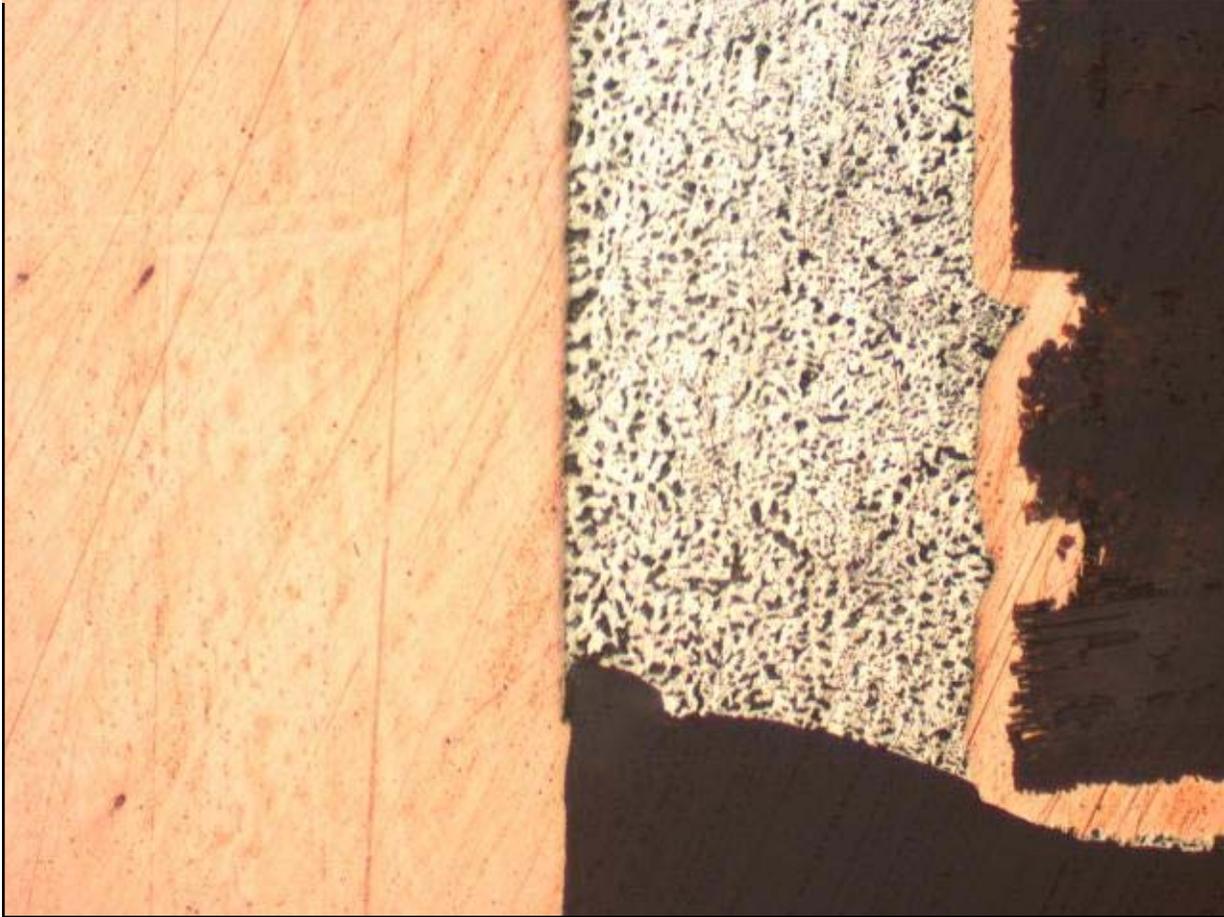
57 - Optical image of pin 5 from K222. No signs of cracking were visible.

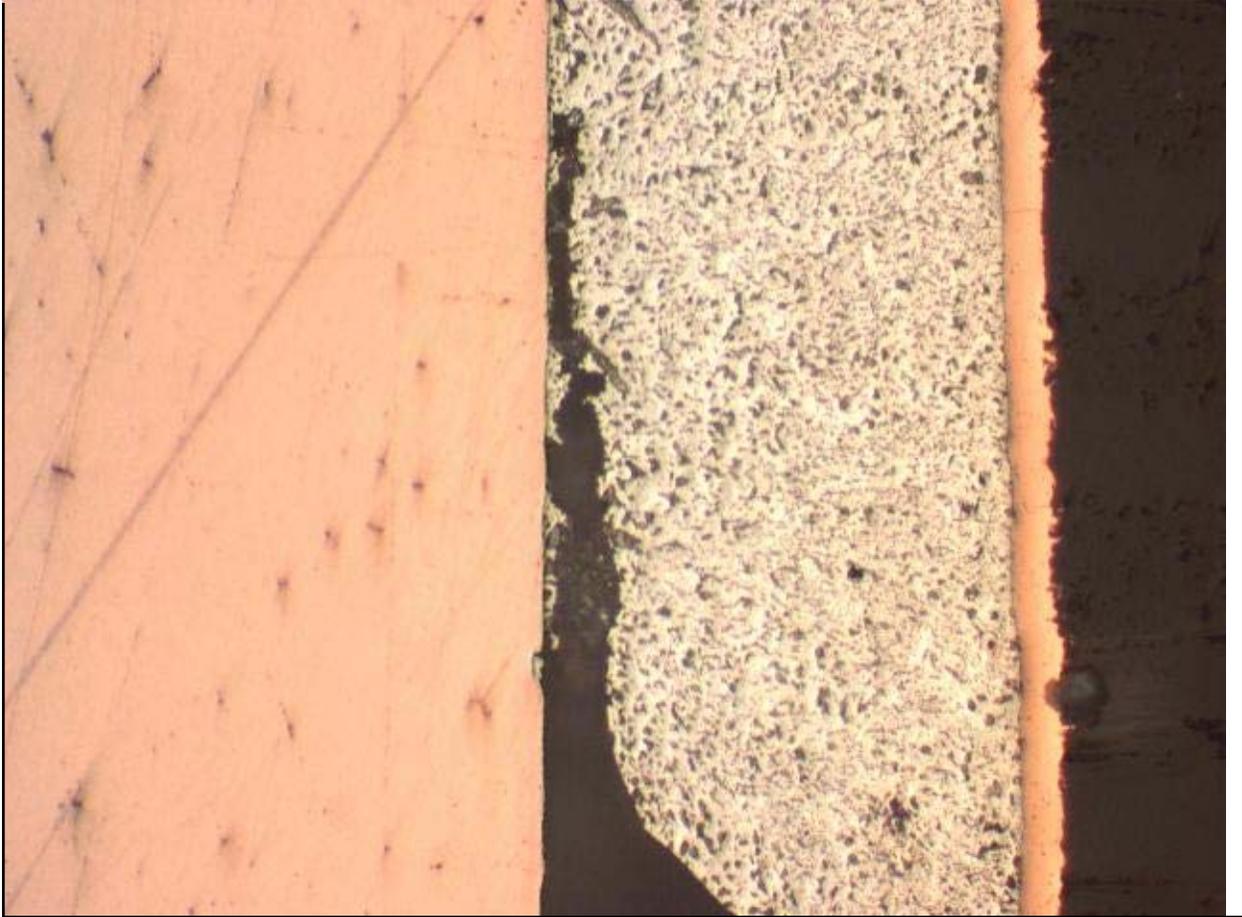
61 - Optical image of pin 1 from K230. No signs of cracking were visible. The solder appeared to be grainy.

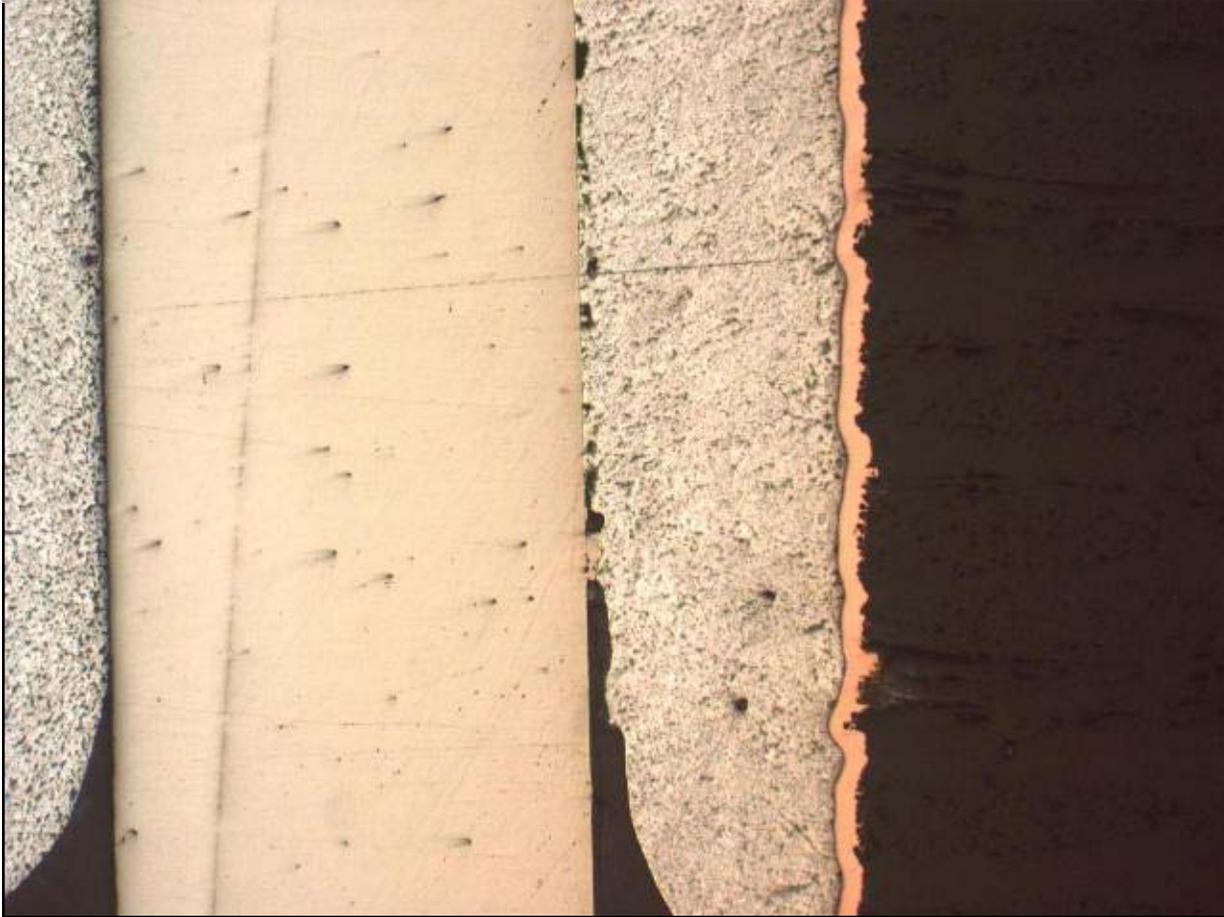
71 - Optical image of pin 4 from K230. No signs of cracking were visible. the solder appeared shiny.

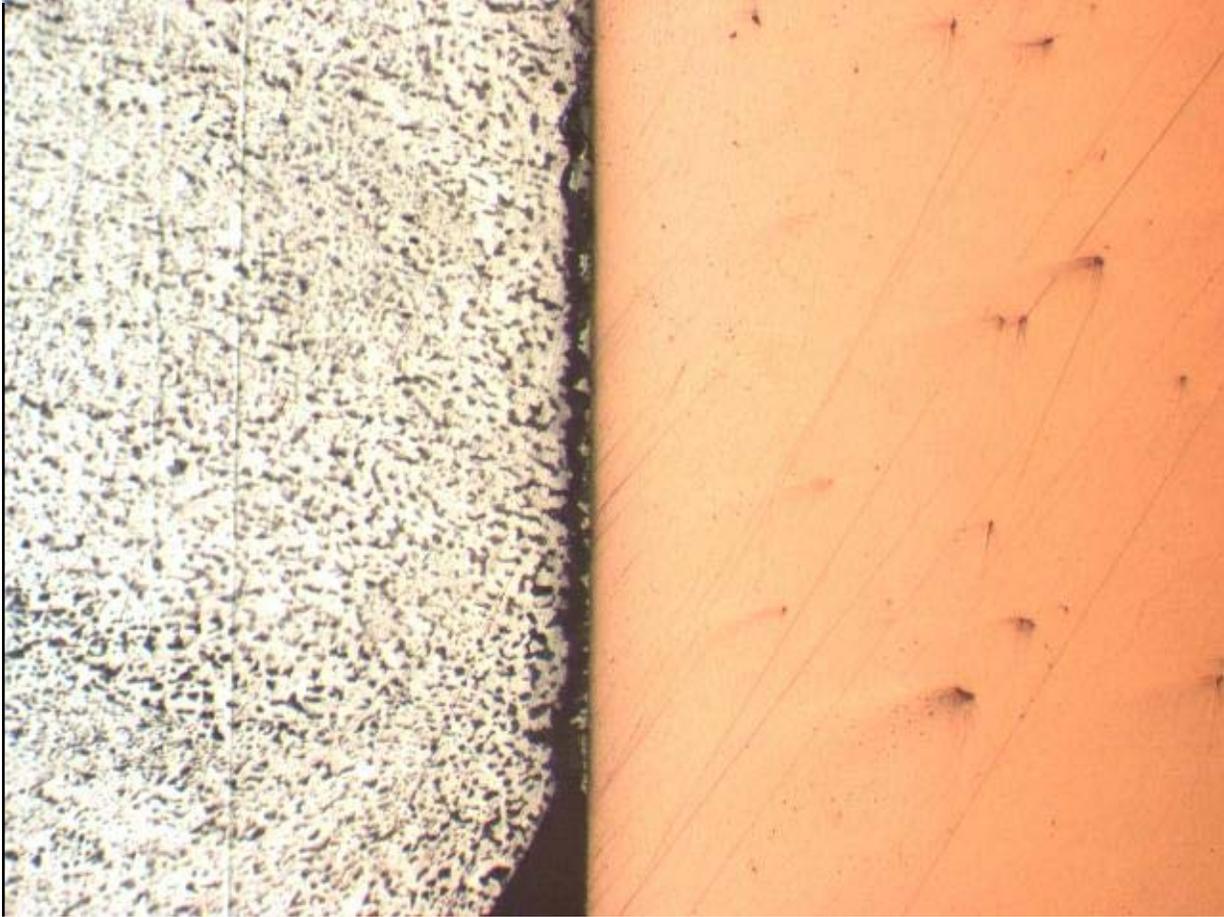
73 - Higher magnification image of the left side of the pin.

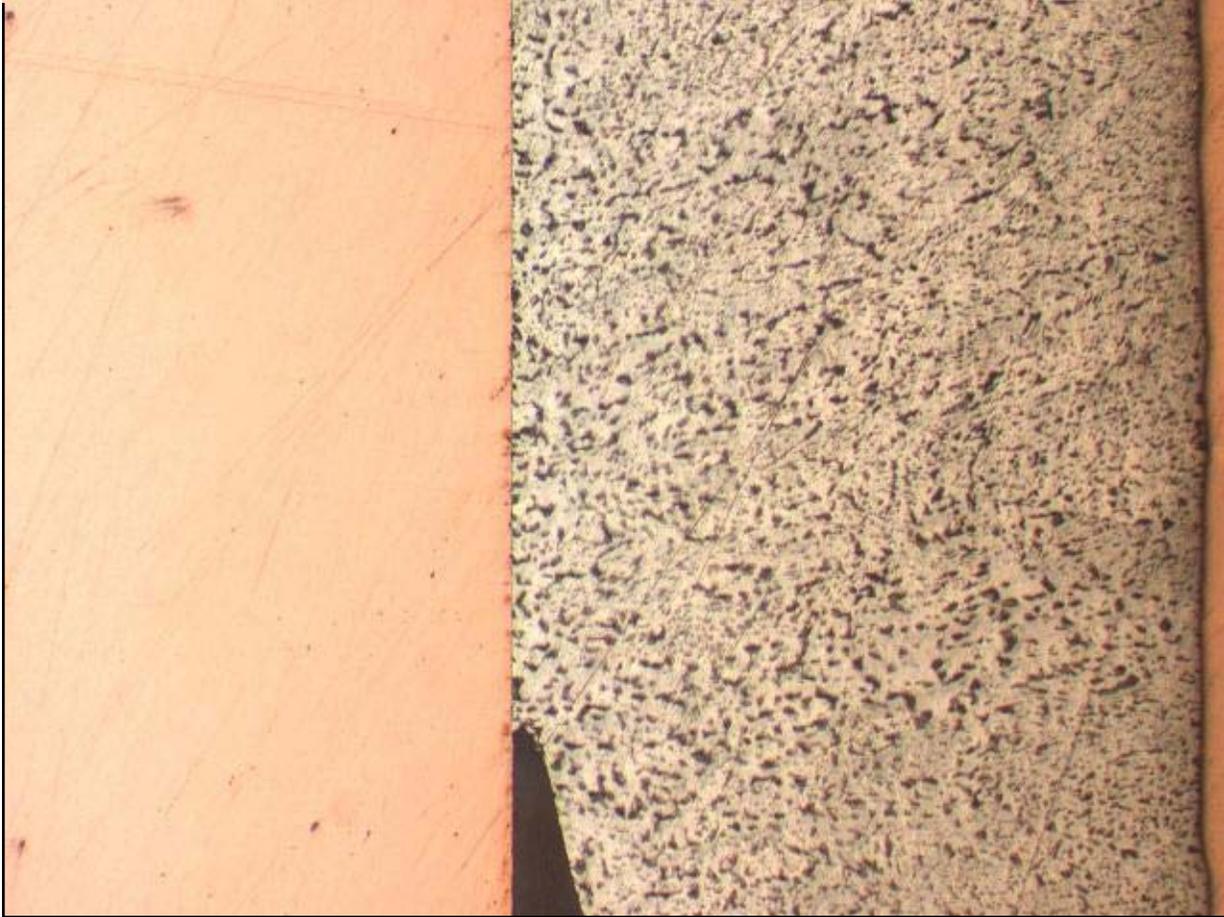
74 - Higher magnification image of the right side of the pin.

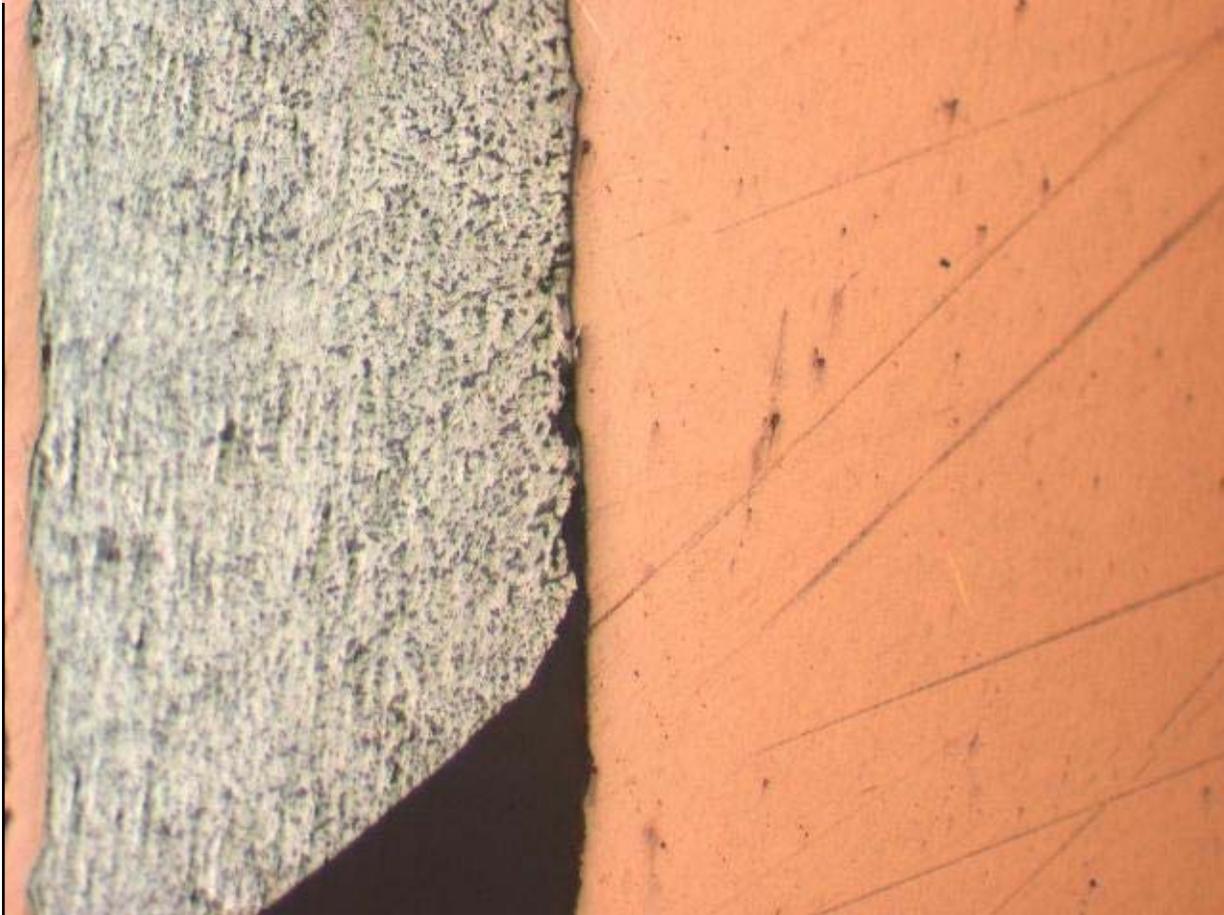
77 - Higher magnification image of the left side of the pin.
